*Using Photogrammetry
to Monitor
Materials Deterioration
and Structural Problems
on Historic Buildings*

*The Dorchester Heights
Monument:
A Case Study*

**U.S. Department of the Interior
National Park Service
Preservation Assistance Division**

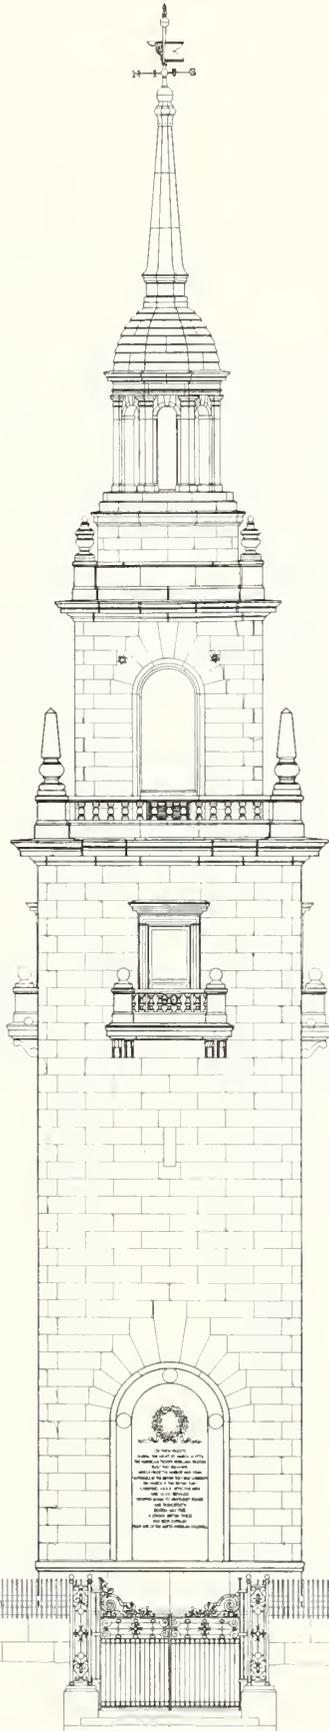
WEST MONUMENT ELEVATION
(SEE WEST ELEVATION OF TOWER BASE, SHEET NO 3)

MANY OF THE INDIVIDUAL MASONRY UNITS HAVE BEEN PUSHED OUT OR HAVE SHIFTED. DOCUMENTATION OF THIS MOVEMENT IS CONTAINED ON THE ORIGINAL PENCIL DRAWING PRODUCED BY THE STEREOPLOTTER

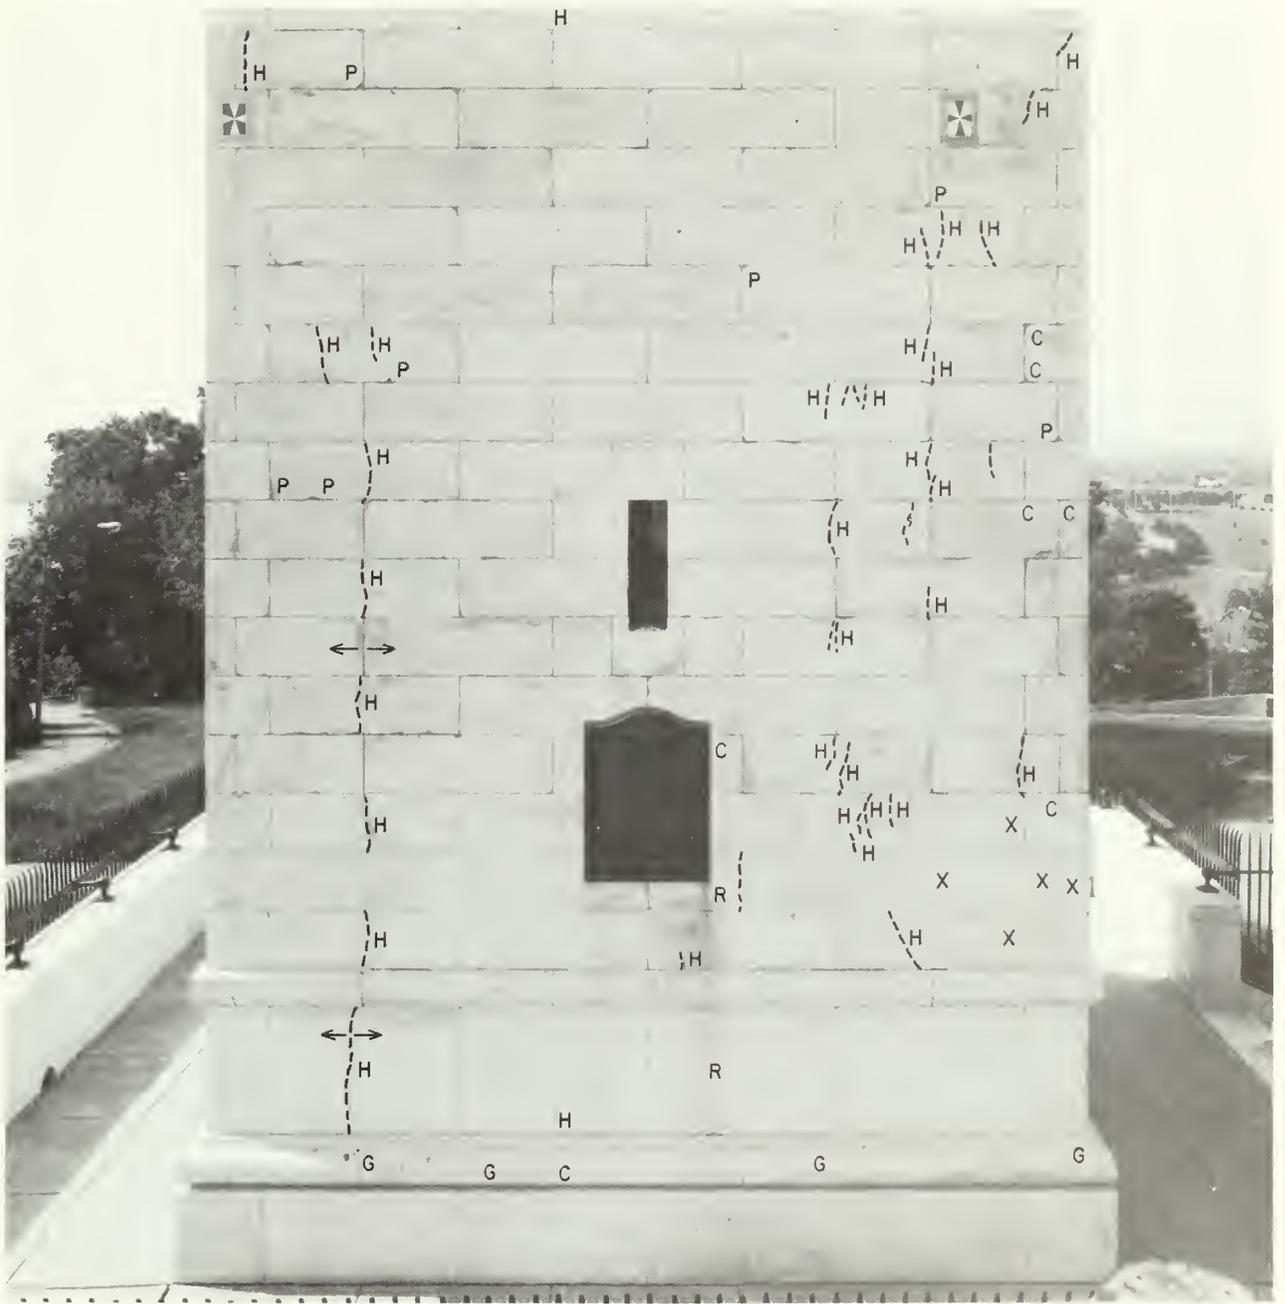
Figure 3A

Figures 3A-3F. The following photographs of the north elevation, Dorchester Heights Monument, display surface deterioration, prior patching and structural movement. Note the preponderance of hairline cracks, especially in the lower portions of the monument, and that the hairline crack visible in the lower left portion of 3A extends upward through about 13 courses, splitting the stones in every other course, extending about 18' from the base of the monument, indicating a pervasive movement within the structure. A number of the stone blocks have moved ahead of the wall plane, especially in the upper portions of the tower, seen in photograph 3D and 3E, and a number of the mortar joints have opened up, some approaching 1" or more.

The materials deterioration and structural problems recorded here can be used to monitor the condition of the structure over the course of time and to develop treatment strategies. (The photograph of the spire end weathervane, figure 3F, was not annotated.)
