DIGITAL PHOTOGRAMMETRY: A STANDARD APPROACH TO CULTURAL HERITAGE SURVEY

Andrea Lingua^a, Paolo Piumatti^b, Fulvio Rinaudo^a

The present work shows an application of digital photogrammetry to the survey of the remains of a church which will be converted into a conference hall for the University.

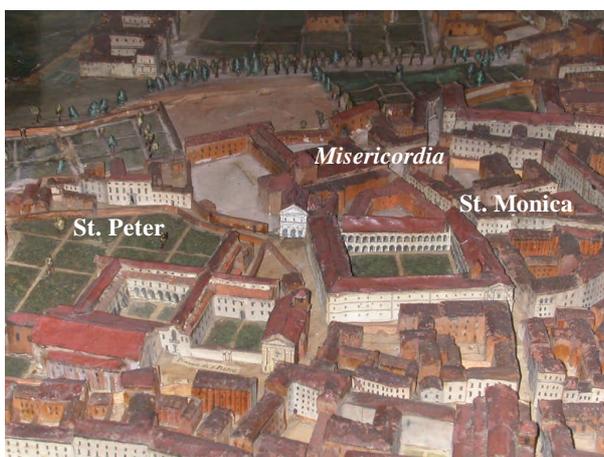
Figure 1. Urban hand made 3D model (M. Nicolosino, 1815) showing the church and the surrounding religious buildings (Local Museum of Savigliano)

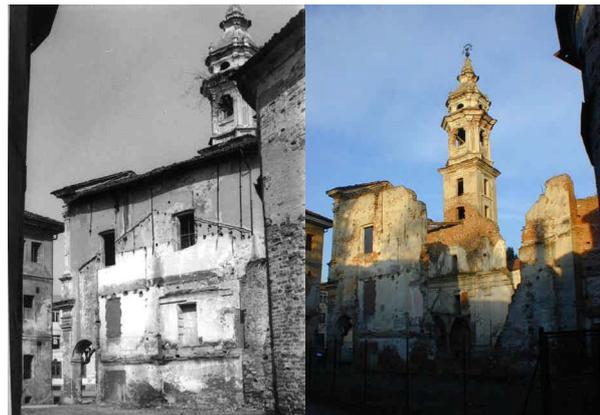
Figure 2. The church before and after the damage of 1984

Since then *Croce Nera* church has been a ruin: the roof, the vaults and part of the flanks and the apse have collapsed. The area where the church stands is still off-limits (see Fig. 2).

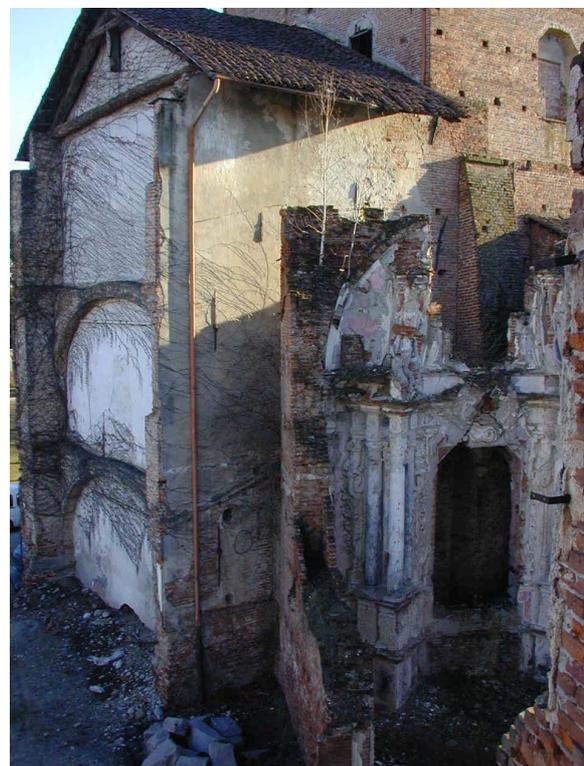
Figure 3. Rests of the vaults

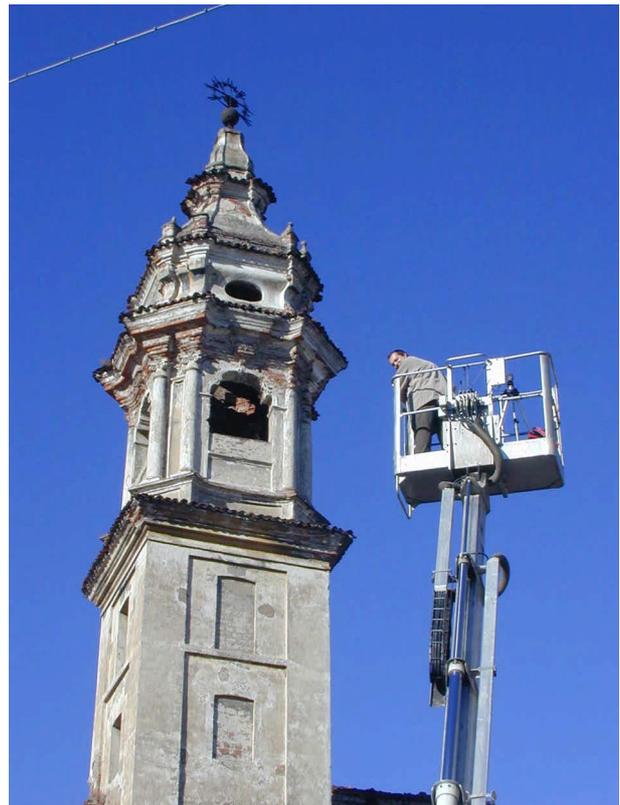
Figure 3. Photogrammetric taken of the bell tower

The images have been acquired by means of the semimetric ROLLEI 6008 camera ($f = 40$ mm): the scales of the images range from 1:800 to 1:400. In order to avoid perspective occlusions all the images have been recorded in the normal case of the photogrammetry. The images of the top parts of the buildings have been acquired by using "ad hoc" solutions (see Fig. 3).

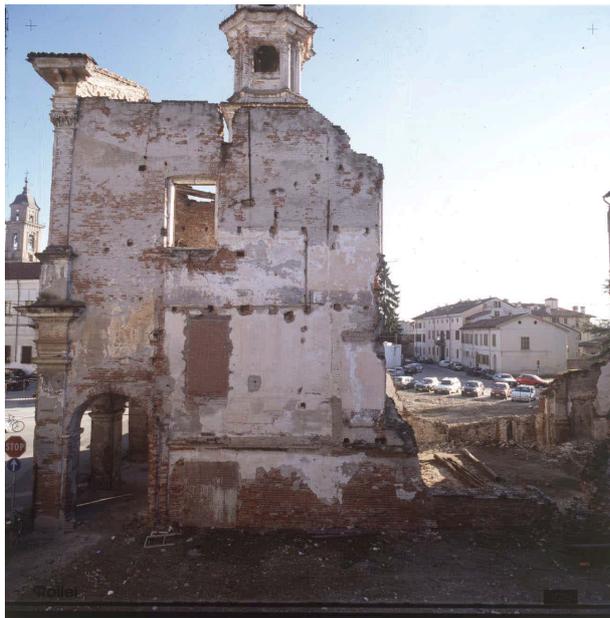
Figure 4. Semimetric image of the church

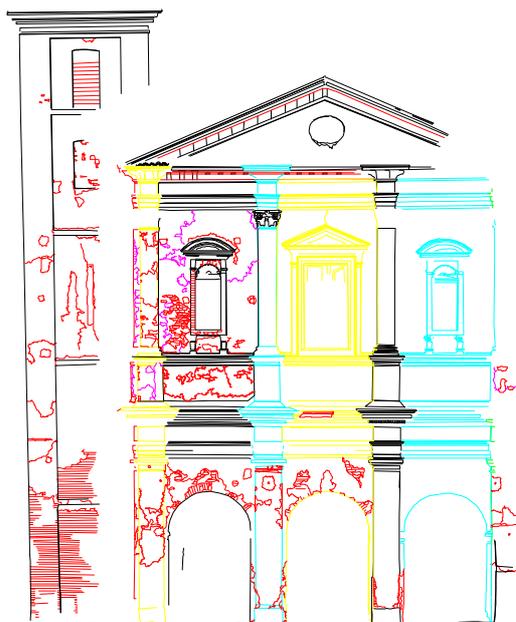
30 of the 70 acquired images have been used during the restitution of the church. More than 25 logical levels of information have been used during the collection of the geometric data. Figure 5 shows the results of the plotting executed on the main façade of the church: different colours demonstrate the interpretation and classification performed during the restitution by the operator.

Figure 5. Plotting results of the main façade
