## **DOCUMENTATION OF A VERNACULAR HOUSE WITH CLOSE-RANGE DIGITAL PHOTOGRAMMETRY**

İ. Akbaylar, M. Hamamcıoğlu-Turan

This study aims to present a combined documentation method that can be easily applied on the built vernacular heritage prior to establishment of appropriate conservation methodology and treatment strategy. It takes into consideration the vernacular house type of Alaçatı, İzmir, Turkey and defines the appropriate techniques to be used in the conservation aimed analytic recording process. The prismatic house masses at human scale, with plain façade orders and orthogonal plan layouts at this settlement can be recorded fast and accurately with close-range digital photogrammetry. The concepts of mapping should be utilized for the representation of analytic data. Within this frame, a 19<sup>th</sup> century house located in the urban conservation site of Alaçatı is to be presented as the case study.

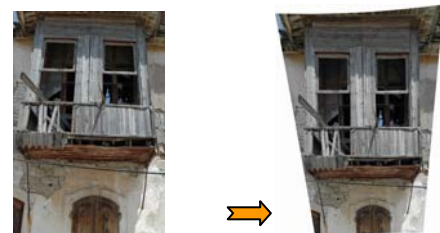
Figure 4. An original photograph and its orthoimage

Rectified images of the studied façade are brought together in Photoshop, and the orthoimage is created. For the scaling of the orthoimage, 3D measurements of a limited number of points (approximately 4 points for each photograph) are transferred from Pictran to CAD, and then to Photoshop.

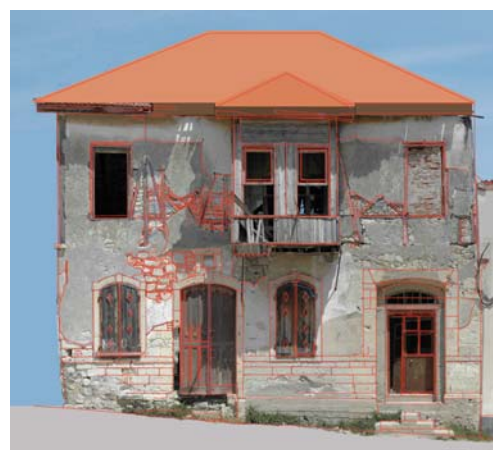
Figure 5. The orthoimage of the southern façade, overlapped with the 2D scaled drawing

The roof, which is an inclined surface, is not rectified since it is not shot parallel to its plane. Similarly, the eaves are not rectified because they are not viewed close to the center of any parallel photograph (Hanke et al., 2002). So, they all appear

white in color. Therefore, they are filled with realistic colors so that the façade can be perceived as a unity. The sky and the ground are also represented with realistic in-fills so that the gap effect is avoided. Nevertheless, the textures of the filled in parts and the rectified ones can be differentiated in close inspection.

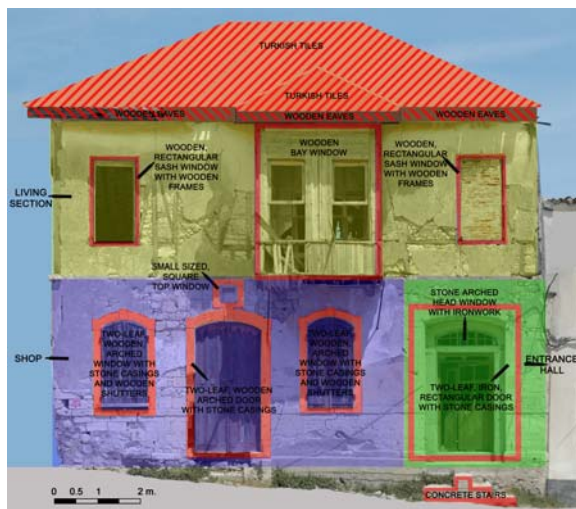
| <b>SPACES</b> | | |
| Shop (1) | | |
| Entrance hall (2) | | |
| Living section (3) | | |
| <b>ELEMENTS</b> | | |
| Turkish tiles (4) | | |
| Wooden eaves (4) | | |
| <b>Doors</b> | | |
| Two-leaf, wooden, arched doors with stone casings (5) | | |
| Two-leaf, iron, rectangular door having a stone arched head window decorated with ironwork (6) | | |
| <b>Windows</b> | | |
| Two-leaf, wooden, arched windows with stone casings and wooden shutters (6) | | |
| Wooden, rectangular sash windows with wooden frames (7) | | |
| Small sized, square top window (7) | | |
| Wooden bay window (7) | | |
| Concrete stairs (7) | | |

Figure 6. Analysis of Spaces and Architectural Elements

At the ground floor, the entrance doors of the shop are two-leaf, wooden and arched with stone casings. The windows are two-leaf, wooden and arched with stone casings and wooden shutters. The main entrance door is a two-leaf, iron door with a head window decorated with ironwork. At the first floor, there are wooden windows with vertical sashes. The bay window is carried by timber beams and supported by iron bars. Wooden eaves and the hipped roof covered with Turkish tiles are the other façade elements.

The legends of the thematic maps are determined as “Spaces and Architectural Elements” (Figure 6), “Structural Characteristics” (Figure 7), “Alterations” (Figure 8) and “Structural Failures and Material Deteriorations” (Figure 9). The analytic concepts, their graphic codes and detail photographs for each theme are gathered on separate tables. Then, the orthoimage is processed for each theme separately in the image evaluation software (Photoshop) and the thematic maps are produced.

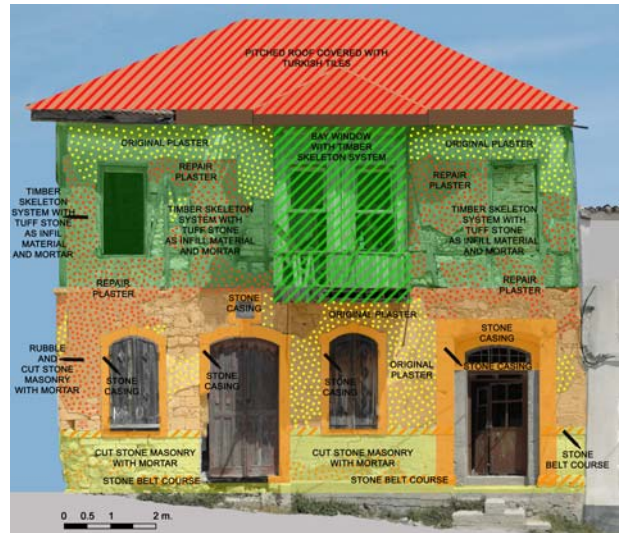
### WALLS

#### First floor walls:

| | Timber skeleton system with tuff stone as infill material and mortar (1) | |
| | Plaster layer on the exterior façades of the walls | |
| | Original plaster layer (2) | |
| | Repair plaster layer (2) | |
| | Bay window with timber skeleton system - carried by timber beams, supported by iron brackets (3) | |

#### Ground floor walls:

| | Rubble and cut stone masonry with Mortar (4) | |
| | Cut stone masonry with mortar (5) | |
| | Stone casings at the windows, stone arches on top of the window openings (6) | |
| | Stone casings at the doors, stone arches on top of the door openings (6) | |
| | Stone belt course (7) | |

### ROOF

| | Hipped roof covered with Turkish tiles (8) | |

Figure 7. Analysis of Structural Characteristics

When structural characteristics and elements of the house are considered; rubble and cut stone masonry, and thick plaster are observed at the ground floor walls. At the first floor walls, timber skeleton system and tuff stone as infill material are used. Horizontal wood beams and planks form the flooring system. There are wood lintels on the wooden windows. Timber posts for the partition walls at the first floor and rubble stone foundation are observed. The staircase is wooden.
