Historical aerial photographs for landslide assessment: two case histories

J. Walstra, N. Dixon and J.H. Chandler

Quarterly Journal of Engineering Geology and Hydrogeology, 40, 315–332, 2007.

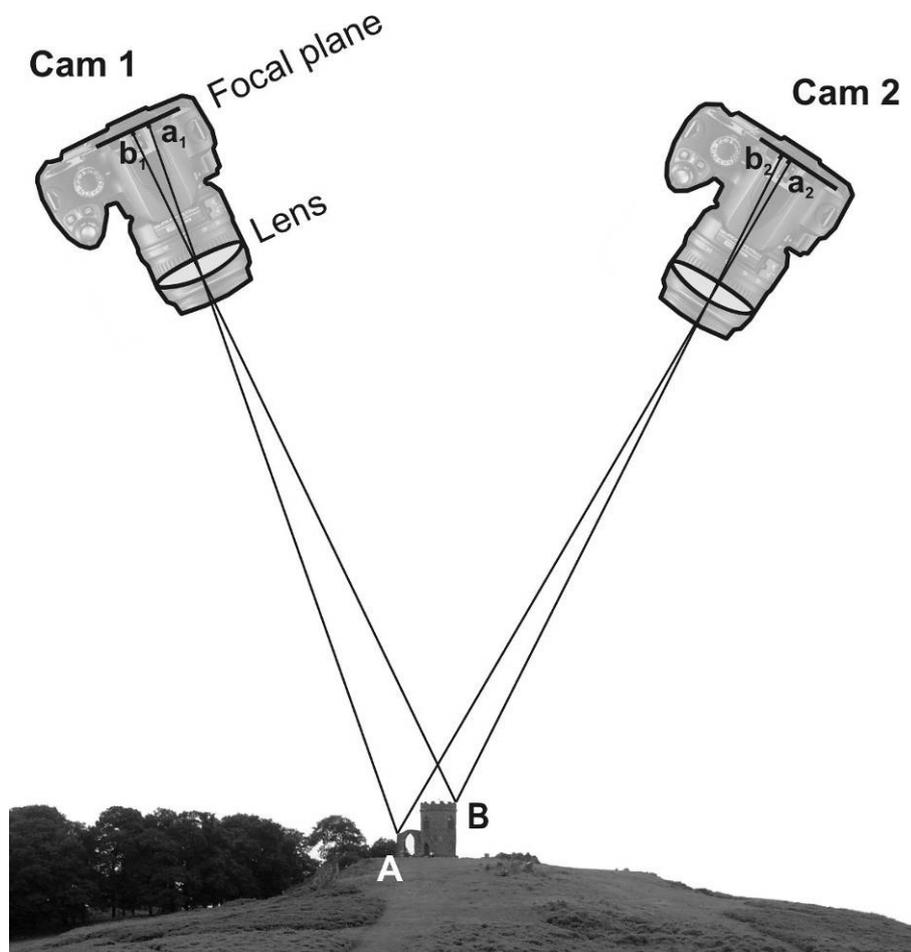
Fig. 1. *The principles of photogrammetry: bundles of light rays pass from object points (A & B) through the perspective centre of the camera lens onto their corresponding image points (a & b) in the focal plane. Using two photographs from different camera positions (Cam 1 & Cam 2), three-dimensional object coordinates can be determined by intersecting the reconstructed bundles of light. Some important parameters required for this procedure are the principal point and focal length of the camera.*

Theoretical principles underlying photogrammetry were established over a century ago and further developed for map production in the 1930s (Wolf & Dewitt 2000; Slama 1980). The main concept of photogrammetry is collinearity, whereby an object point, the projection centre of a lens, and its corresponding image point on the focal plane lie along a straight line (Figure 1). Using this principle, three-dimensional coordinates can be extracted from any stereopair of photographs, provided that the inner geometry (interior orientation) and the position and orientation of the camera at the moment of exposure (exterior orientation) are known. However, a bundle of light rays will never pass from the object through the camera lens system and onto the imaging device in a perfectly straight line. Therefore, for accurate photogrammetric work corrections have to be made for lens distortion, atmospheric refraction and earth curvature (Wolf & Dewitt 2000).

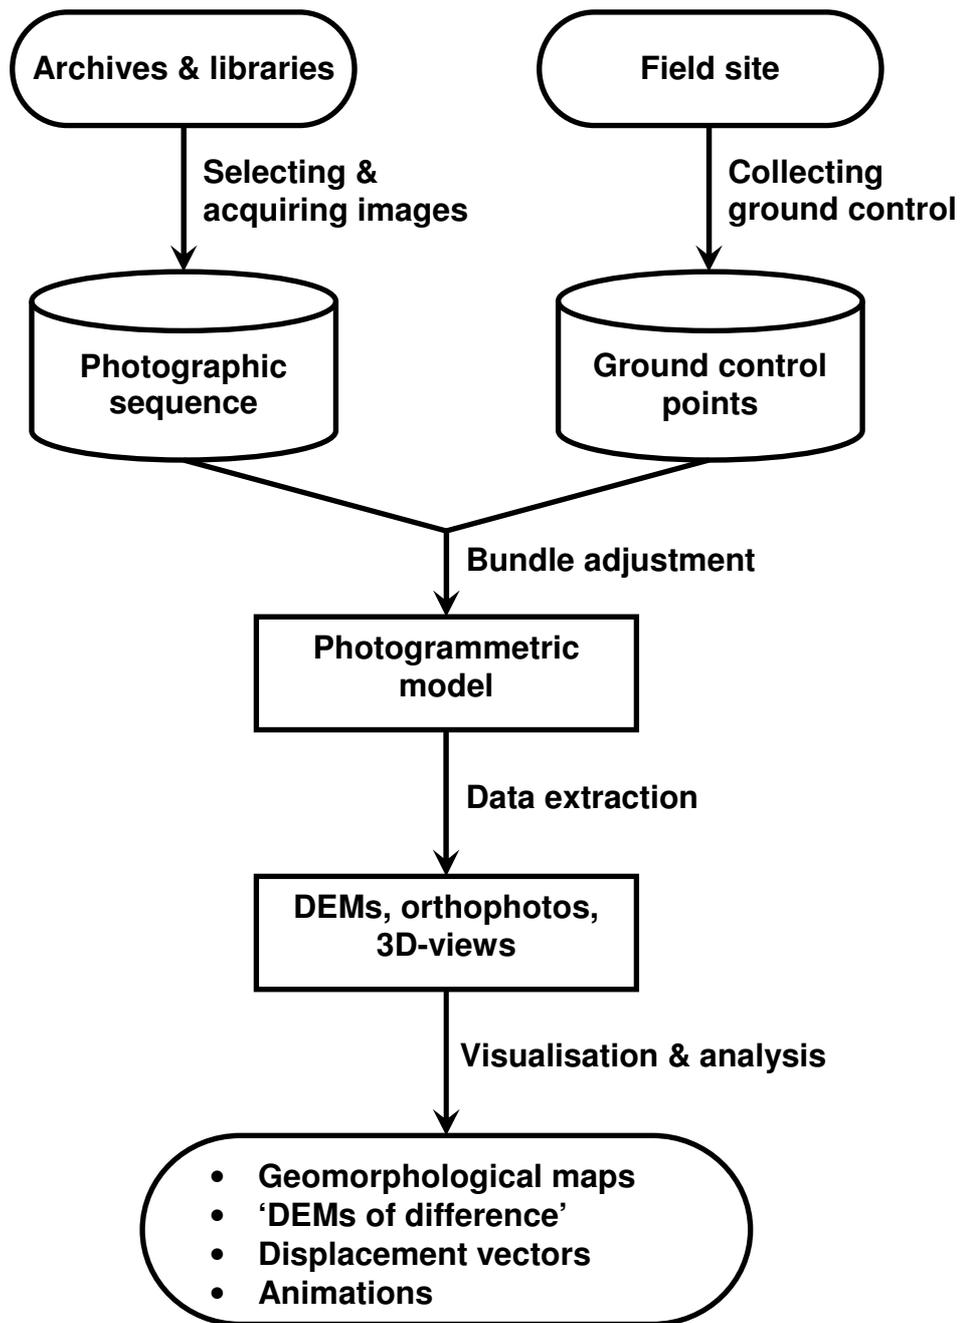
Fig 2. *Flowchart of the general working process adopted in this study.*

The working process adopted in this study can be divided in four general stages. Firstly, suitable images were acquired. Then, ground control data were collected, using differential GPS. The next stage comprised the restitution of the photogrammetric model and data extraction. The final stage embraced visualisation and analysis of the resulting data. This process is summarised in a flowchart (Figure 2) and described in the following sections.

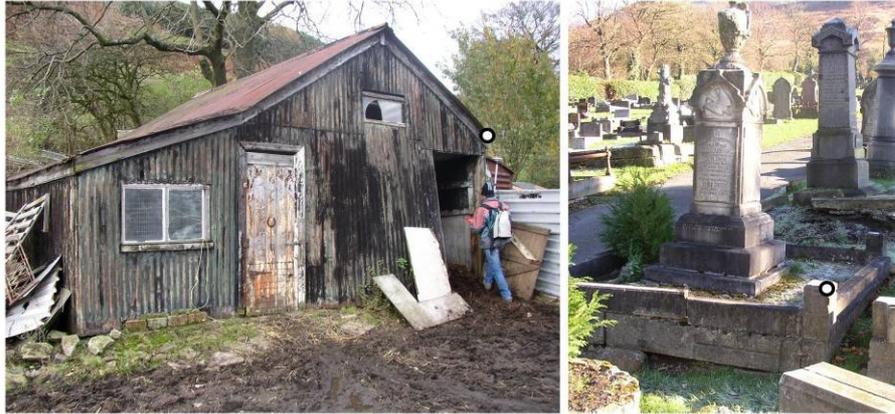
Fig. 3. *Typical targets for ground control: the corner of an old barn and a gravestone.*

Control points need to be identified and measured both on the photographs and the ground surface. Such control points are required for establishing the photogrammetric model and referencing it to a ground coordinate system, i.e. defining the geometrical datum. For the work described here control points consisted of physically well-defined features, easily accessible in the field and clearly identifiable on the photographs. An additional issue associated with historical photographs is that measured features need to be stable since the moment of image capture. Typical control points used included the corners of old buildings, stonewalls and gravestones (Figure 3). A minimum of two planimetric and three height points is needed to define a datum, but redundant control is desirable to increase the accuracy of the adjustment and for camera calibration. It also provides appropriate checks on data quality. In this study, the control points were distributed evenly over the area of interest to ensure strong geometry in the photogrammetric model.

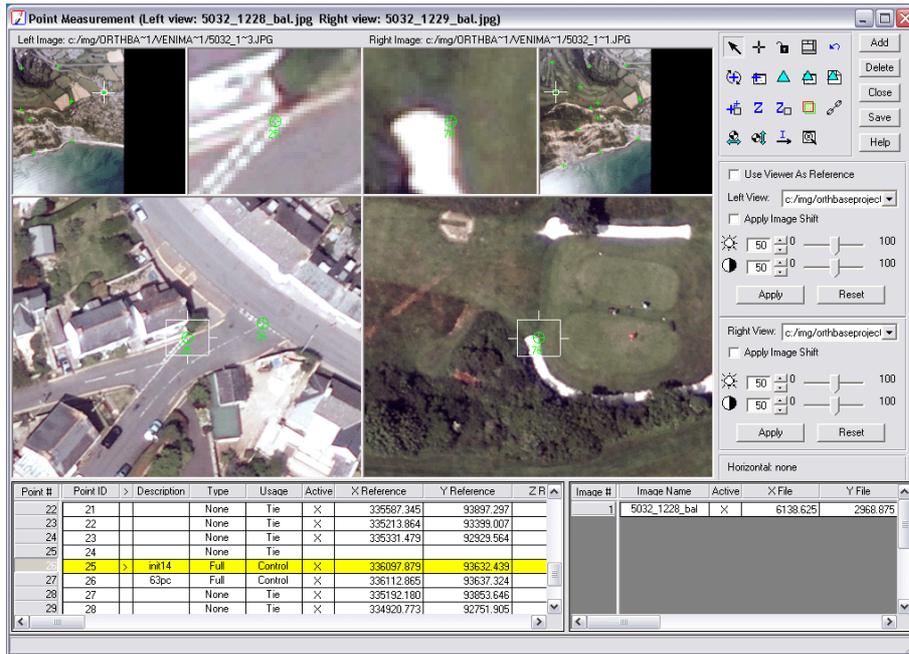
Fig. 4. Screenshot of the point measurement tool in LPS.

Ideally, the camera parameters were available from a camera calibration certificate and simply entered during the adjustment procedure. However, for some of the archival imagery these were missing and had to be estimated in the adjustment through self-calibration; in such cases, input of initial estimates of the parameters was required. Fiducial marks were identified on the images and used to define a 2D affine transformation between image and photo coordinates. Control points were identified and measured on the images in the graphical interface of LPS' point measurement tool, and their corresponding ground coordinates manually entered (Figure 4).

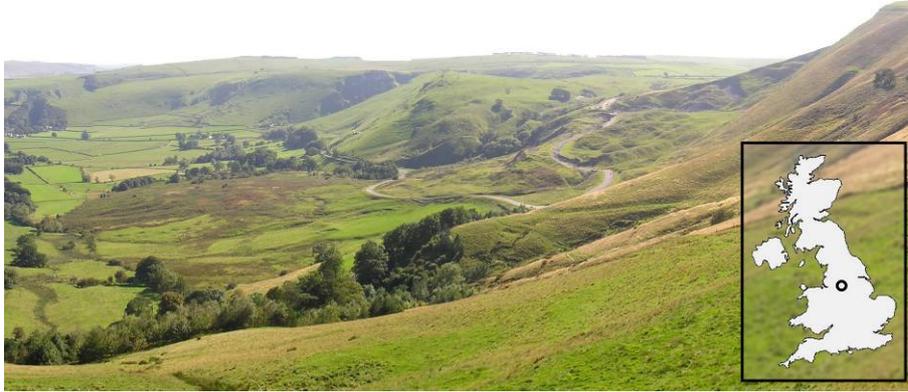
Fig. 5. *The Mam Tor landslide: head scarp on the right, debris slide on the left side, and the abandoned road crossing the central area. Inset: location of Mam Tor.*

This landslide (Figure 5) is situated on the eastern flank of Mam Tor, just below the summit (517mOD) at the head of Hope Valley in Derbyshire, UK (Ordnance Survey coordinates SK135835). The former main road between Sheffield and Manchester (A625) was constructed across the slide, but abandoned in 1979 as a consequence of continual damage due to the moving ground mass. The initial rotational failure, in a slope consisting of sandstone sequences overlying shales, has been dated back to 3600 BP (Skempton *et al.* 1989). While advancing downhill, the mass broke into a complex series of blocks and slices, eventually creating a debris mass. The most active part moved 0.35

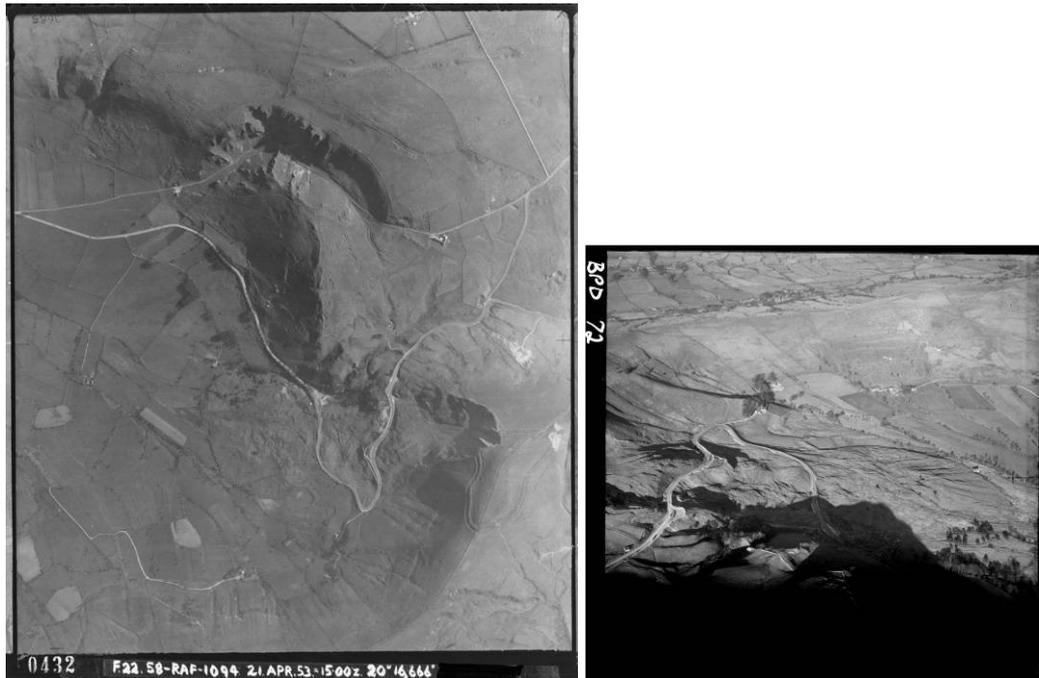
Fig. 6. Typical examples of archival photographs: the Mam Tor landslide on a vertical RAF image from 1953 (left) and the central part of the landslide as seen from the west on an oblique image from 1973 (right; copyright reserved Cambridge University Collection of Air Photographs). These examples clearly illustrate that available material do not always have the ideal qualities for photogrammetric analysis. The RAF image was taken from great height and is hazy; in the oblique image large parts of the landslide are obscured by shadows.

A search for aerial photography of Mam Tor revealed a large number of images available from 1947 until present. From a geomorphological point of view it was desirable to have an extensive sequence separated at regular intervals, to obtain a record of the development of the landslide. From a photogrammetric perspective it was of interest not only to acquire the best-quality photographs, but a variety of formats, scale, media and quality. This provided an opportunity to investigate the application of the photogrammetric techniques to commonly available photographic archival material. A photographic sequence including eight different epochs was composed, covering a period of almost half a century: 1953, 1971, 1973 (vertical and oblique images), 1984, 1990, 1995, 1999. Table 1 summarises the characteristics of the acquired photographs; two typical examples of archival images are displayed in Figure 6.

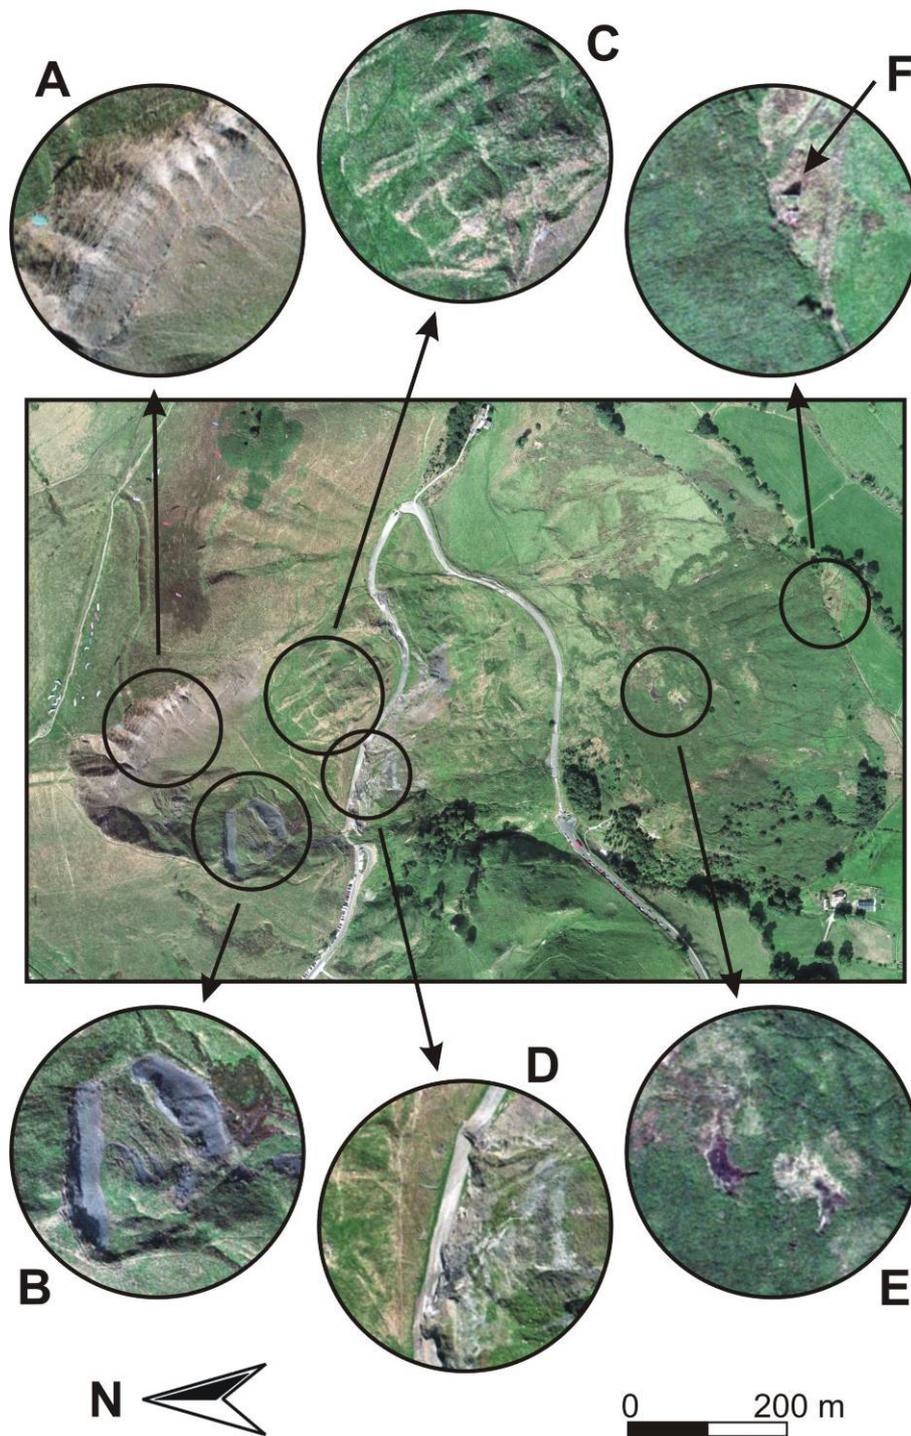
Fig. 7. Characteristic features of the Mam Tor landslide, visible on the 1999 images: head scar (A), regressive failure (B), irregular topography (C), destroyed road (D), ponds and bracken (E), Blacketlay Barn (F).

Characteristic features of the landslide can be observed on the aerial photographs (Figure 7), especially when viewed in 3D. The most striking feature of the landslide is the head scar standing up a height of 80 m in the Mam Tor sandstone beds (A); active rockfalls supply the colluvium below with fresh scree, which form well-defined fans. Regressive failures have occurred in the southern part of the head scar and in the colluvium material (B). The upper part of the slide mass consists of largely intact blocks forming an irregular topography (C). At the front of this zone, individual blocks are breaking up thereby developing large steps in the upper road section (D). This zone is bounded upslope by a scarp, marking the steeper inclined slip surface. The material from this cliff breaks up into a debris slide, extending further downhill. The plastic behaviour of the debris slide is

demonstrated by the distortion of the lower road section which is badly twisted and sheared. The debris slide lobe forms an undulating topography, badly drained as is reflected in the presence of several ponds and bracken (E). The presence of more developed vegetation cover along the southern margins suggests little movement in this part. The northern part of the toe is steeply inclined and its progression led to the destruction of Blacketlay Barn (F) (Waltham & Dixon 2000).

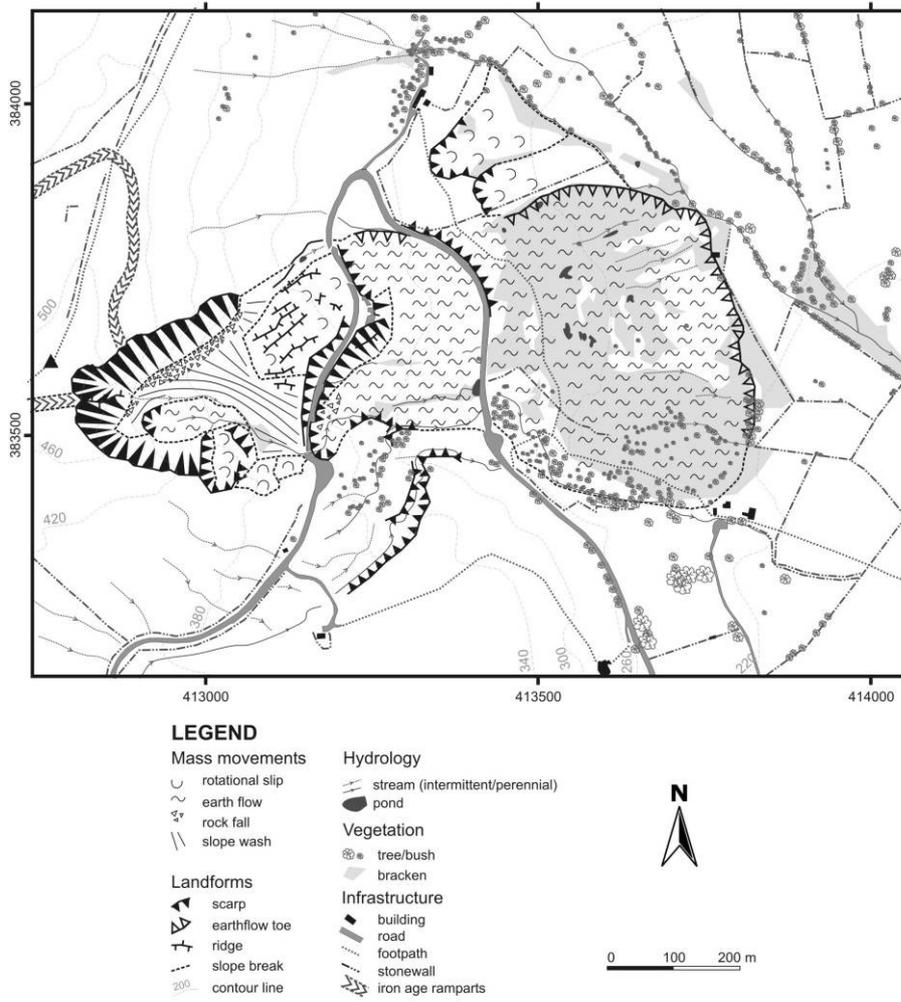
Fig. 8. A geomorphological map of the Mam Tor landslide, created through photo-interpretation of the 1990 images.

A detailed geomorphological map of the landslide area was created through photo-interpretation of the 1990 images (Figure 8). The location of major geomorphological units remained unchanged during the entire image sequence (1953-2000), and therefore it was not justified to map these from the different epochs. Even so, this single geomorphological map proved to have great value for identifying the different elements in the landslide body and help interpret the quantitative data that were extracted from the photographs in later stages.

All surface features clearly indicated a rotational type of movement in the upper part (arc-shaped scarp, transverse cracks dividing the upper body into several blocks, en-echelon cracks along the sides, bulging at the foot) and a flow slide in the lower part (transverse pressure ridges, radial cracks and drainage pattern in lobe).

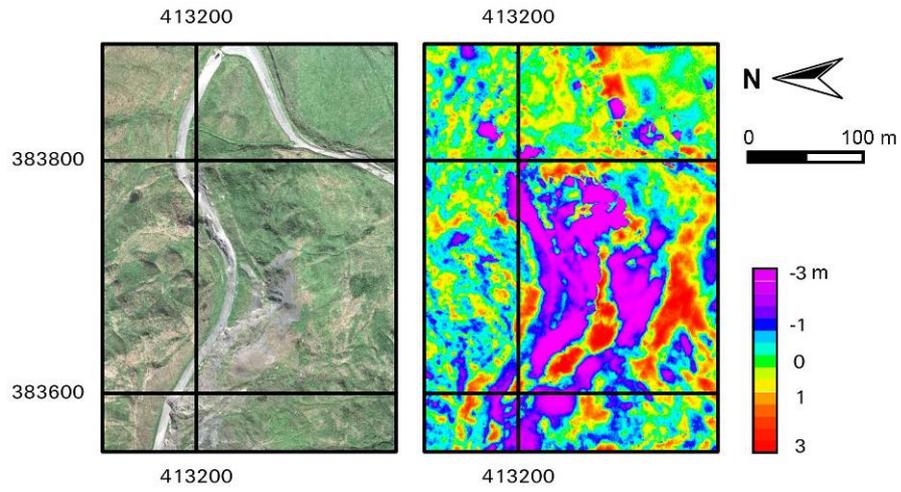
Fig. 9. A 'DEM of difference' of the central part of the Mam Tor landslide, obtained through subtracting DEMs from the 1973 and 1999 epochs.

Considering the relatively small vertical displacements of the landslide compared to the vertical data accuracy that was achieved, it was not possible to detect significant transportation of ground volumes. In spite of their limited quantitative value, the 'DEMs of difference' certainly demonstrated evidence of morphological change that is consistent with the geomorphological processes operating. Figure 9 shows a 'DEM of difference' of the central most active part of the landslide, obtained through subtracting the 1973 and 1999 DEMs. Of particular interest are the transverse pressure ridges, with positive height difference downslope and negative values upslope, which are consistent with downhill displacement.

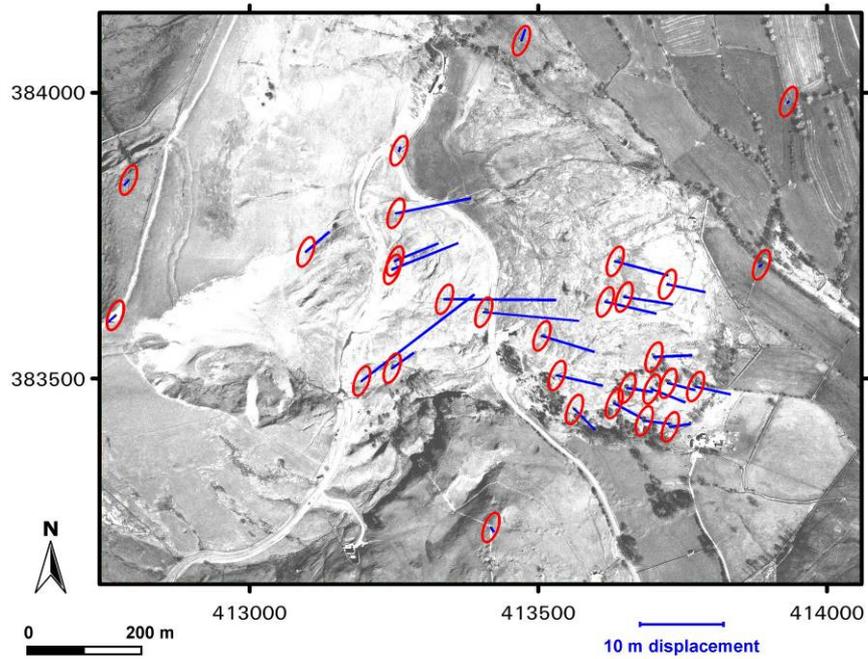
Fig. 10. *Horizontal displacement vectors of the Mam Tor landslide, obtained through measurements from the 1973 and 1999 image epochs.*

The displacements were visualised using vector plots, showing spatial variation in magnitude and orientation during a particular time interval. Figure 10 shows horizontal displacement vectors of the period 1973-1999. Vectors piercing the error ellipses represent significant displacements at a confidence level of 95%. Measurement of targets throughout the image sequence created a time series of displacements and showed the variation through time.

The observed horizontal movement pattern matches the morphological interpretation. The predominantly south-eastern direction of the movements in the upper part of the slide suggests that the slip surface is largely controlled by the dip of the geological strata. In the lower part, the movement direction suggests that the slip surface is controlled by the original hill slope. At the toe, movements tend to be slightly outwards directed, which implies an outward spreading of the flow slide. The large displacements in the upper part of the slip suggest a zone of extension, which corresponds with the observed transverse cracks in this area. Decreasing displacements below the lower road section coincide with the observed pressure ridges.

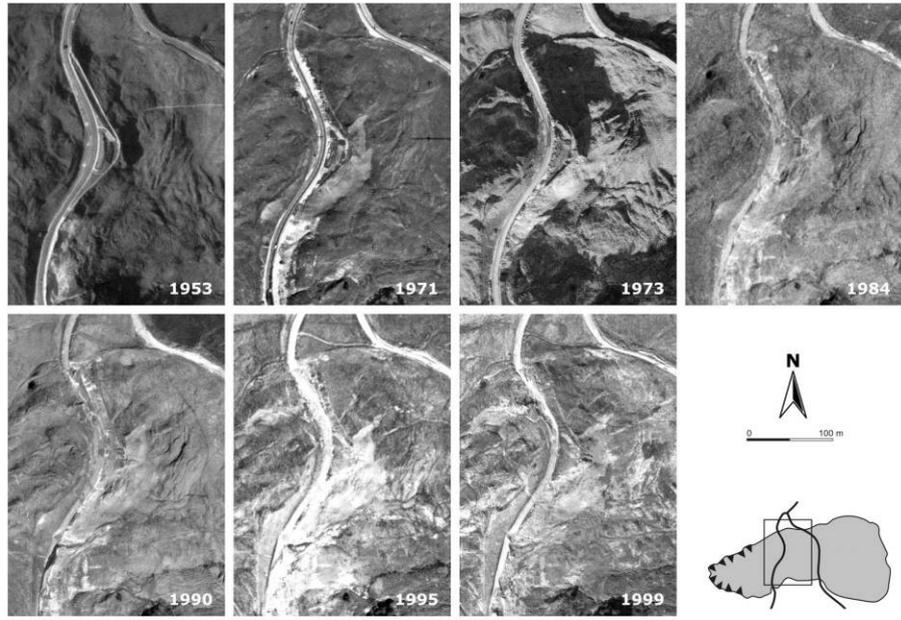
Fig. 11. *An orthophoto sequence of the central part of the Mam Tor landslide.*

An animation created from orthophotos of the central part of the landslide, derived from the image sequence, allowed clear visualisation of the progressive change of the surface (Figure 11). In particular the displacement and disintegration of the road is striking. Draping orthophotos over a DEM provided very realistic three-dimensional views of the site, and were used to produce fly-through animations (Figure 12). The created animations are also available electronically (Walstra 2007).

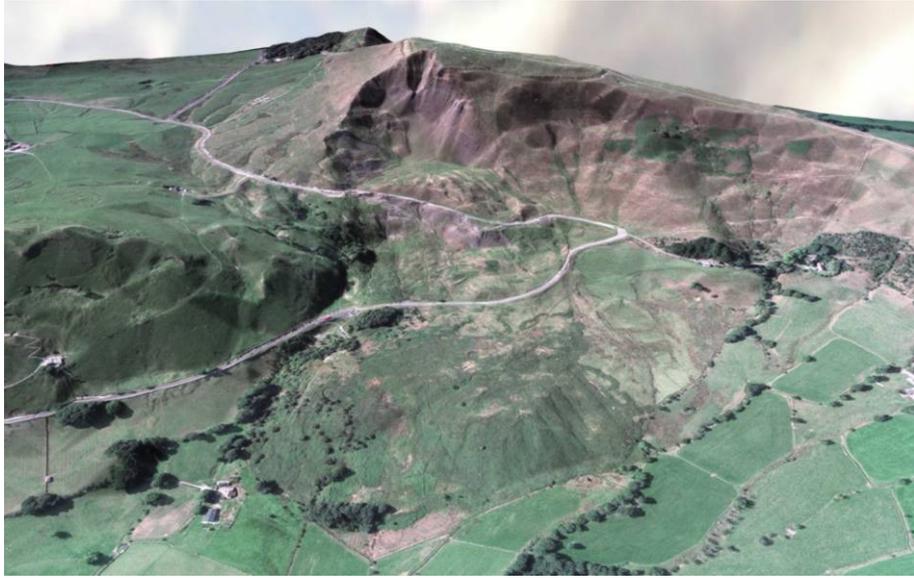
Fig. 12. *A realistic impression of the Mam Tor landslide, created through draping an orthophoto over a DEM, both obtained from the 1999 images.*

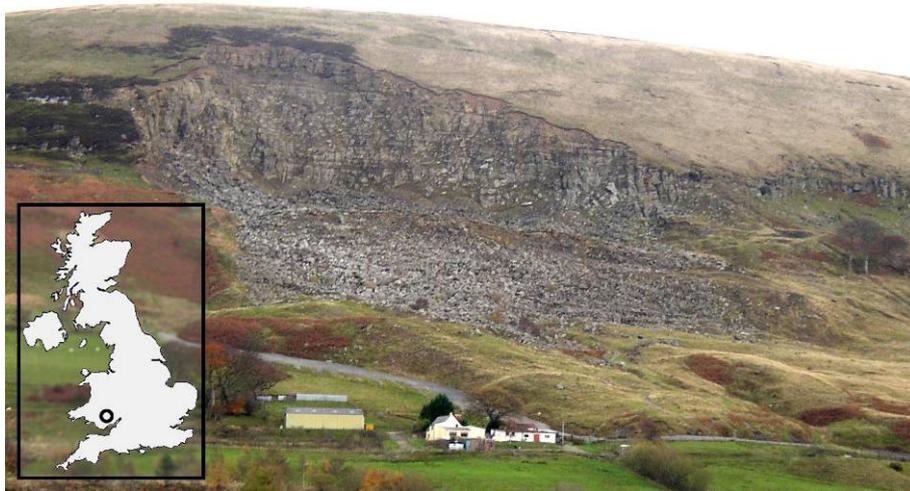
Fig. 13. *The East Pentwyn landslide: head scar visible at the back, the boulder field in the central part and the two vegetated debris slide lobes below. In the forefront is East Pentwyn farm. Inset: location of East Pentwyn.*

The East Pentwyn landslide (Figure 13) is situated on the eastern face of Ebbw Fach valley, south of Blaina, in the South-Wales Coalfield (OS coordinates SO207075). The landslide is a typical example of the many deep-seated rotational failures in this region. These are typically associated with a combination of factors: steep valley sides, thick argillaceous strata and mining subsidence (Conway *et al.* 1980). The primary failure was triggered as recently as 1954. The displaced block disaggregated into a boulder field from which two debris slide lobes developed, advancing downhill. The debris slides eventually led to the abandonment of 12 houses (Siddle 2000). Remedial measures during the 1980s slowed down the continuing movements. Ground movements were monitored to quantify the effects of these works and observe further development of the slide (Jones & Siddle 1988).

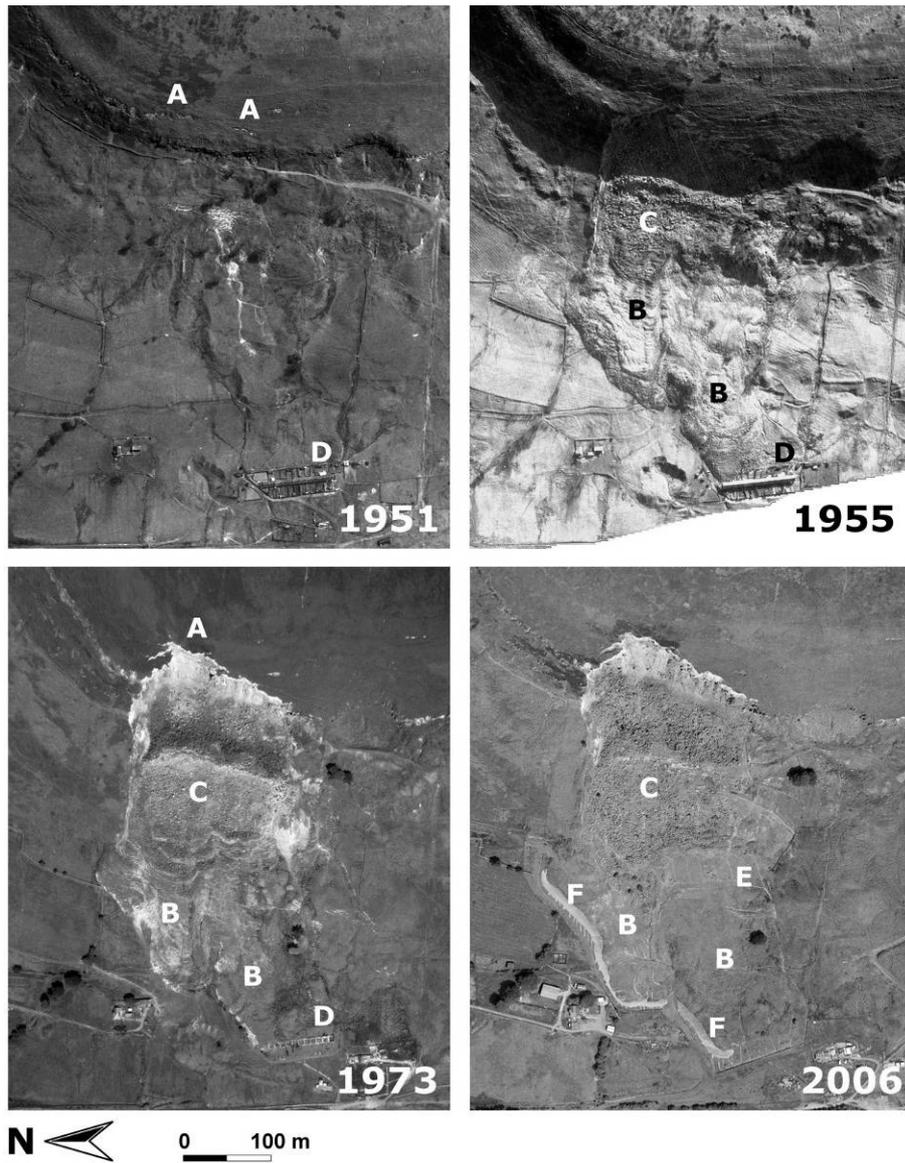
Fig. 14. An orthophoto sequence showing the different stages in the development of the East Pentwyn landslide: situation just before (1951) and after (1955) the catastrophic event, ongoing displacements (1973) and stabilisation measures clearly visible on recent imagery (around 2006; © GoogleEarth). Characteristic features: tension fissures (A), debris lobes (B), boulder field (C), houses of Henwaun Row (D), drains (E), drainage blankets (F).

In spite of their limited use for quantitative measurements, the 1951 and 1955 imagery offered a good opportunity for qualitative analysis. A sequence of orthophotos clearly shows the extent of the major failure that occurred in 1953 and subsequent movements (Figure 14). On the 1951 photographs tension fissures are already visible at the position of the scarp later formed by the failure (A). In spite of the poor image quality, the failure is clearly visible on the 1955 photographs: debris lobes overrode and reactivated the old solifluction lobes (B), reaching all the way down to the houses of 'Henwaun Row' (D). The linear ridges across the lobes suggest a plastic type of movement. The upper part of the mass is covered with scree and boulders (C). Unfortunately, the main scarp is obscured by shadows. The 1971 orthophoto clearly shows that the slide is still very active. The debris lobes at the bottom have extended further down slope and the boulder field has expanded in the central part. On recent imagery from GoogleEarth the stabilisation works are clearly visible: including various drains across the slide (E) and

drainage blankets surrounding the toe of the debris lobes (F). The vegetation cover indicates these works were successful and activity has slowed down.

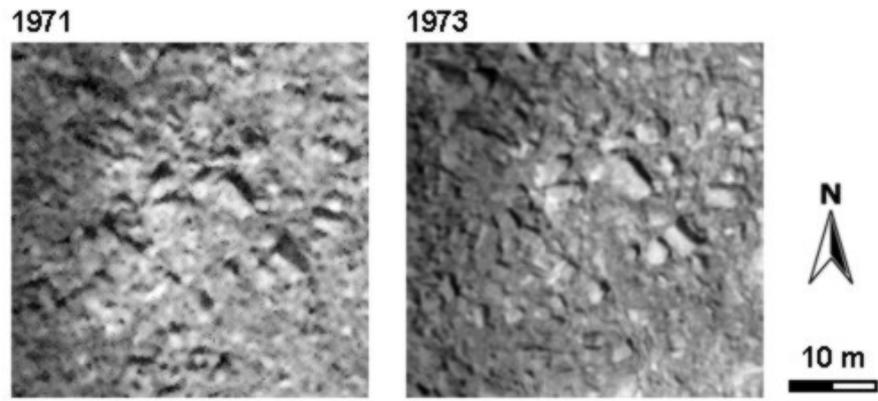
Fig. 15. Othophotos from the 1971 and 1973 images, showing large boulders covering the East Pentwyn landslide surface.

The 1971 and 1973 epochs were specifically selected for extracting displacement vectors. On the photographs the landslide surface is not obscured by vegetation and mainly consists of large boulders that can be identified individually (Figure 15).

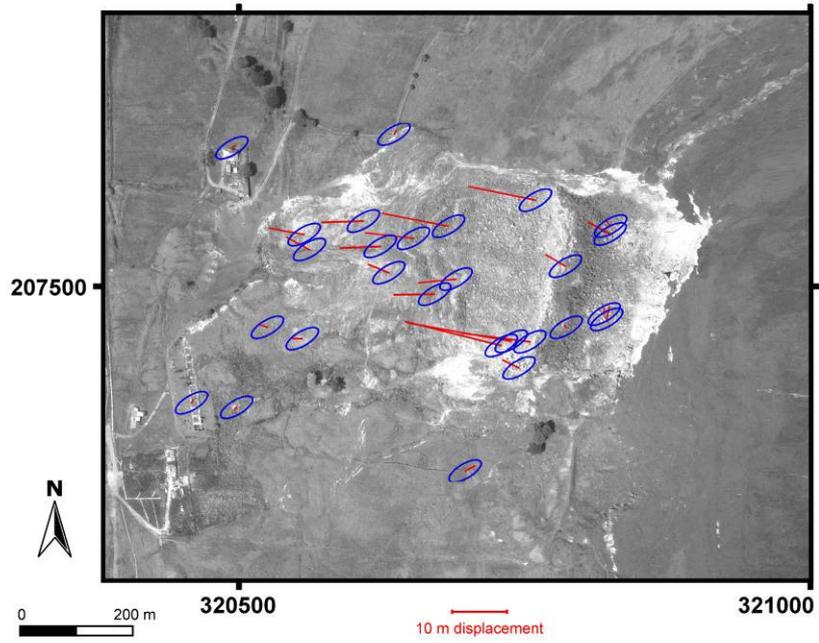
Fig. 16. *Horizontal displacement vectors of the East Pentwyn landslide, obtained through measurements from the 1971 and 1973 images.*

The measured displacements were compared to the monitoring data provided by Halcrow (Halcrow 1983). The Halcrow data comprised repeated monitoring of movement markers located on different landslide elements. Some typical points from the datasets are compared in Table 5. Care must be taken in this comparison since displacements are strongly temporally and spatially variable. Nevertheless, there is a striking resemblance regarding magnitude and direction of the movements. Highest rates were observed in the boulder field (almost 6 m/yr) and the northern debris lobe (over 3 m/yr). The movements of the displaced block and the southern debris lobe were much smaller, and in some cases insignificant.
