Preserving Dinosaur Tracks on Dinosaur Ridge, Morrison, Colorado

By Harold C. Schuch

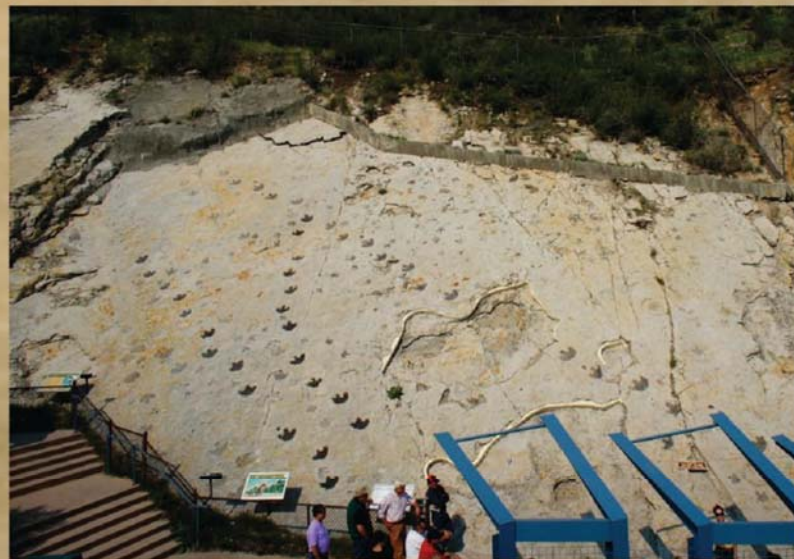
Figure 1. A general view of the site. It consists of a sloped surface (inclined about 36° from the horizon) that contains dinosaur footprints imbedded in sandstone, a layer that is about 150 million years old. Over a dozen different animals left tracks there. Some of the larger tracks appear black because they were rubbed in with charcoal for the tourists.

The "Friends of Dinosaur Ridge" group that manages the site for the town of Morrison, Colorado, was interested in finding a way to measure site deterioration due to climate, and the reduction of the number of footprints due to theft. Figure 1 shows holes in the surface (shored up with metal strips held by rebar) where important footprints have already been removed by thieves. In addition, the group is considering the installation of a roof that covers the site so that tracks can be better protected from the elements. Winds at the site can exceed 160 Km/hr., and snowfalls can exceed 2 m. This means that the roof has to be well engineered.

road crosses in front of the site (just below the photograph in Figure 1 – not shown). The track surface is firm, but covered in a fine sandy dust that makes walking over it very difficult, especially when there is moisture in the air.

The camera used was placed on a tall tripod or lofted higher with the help of a 6 m telescopic pole (as in Figure 1). The 14.2 Mpixel sensor has a format of 23.4 mm x 15.6 mm (4,592 x 3,056 pixels) for the selected 3:2 aspect ratio. This makes the image plane resolution about 5.1 $\mu\text{m}/\text{pixel}$. Images were collected in JPEG format, leaving them at 23.8 Mbytes each. The corresponding GSD (ground spacing distance or pixel footprint) at 50 m therefore was about 16 mm.

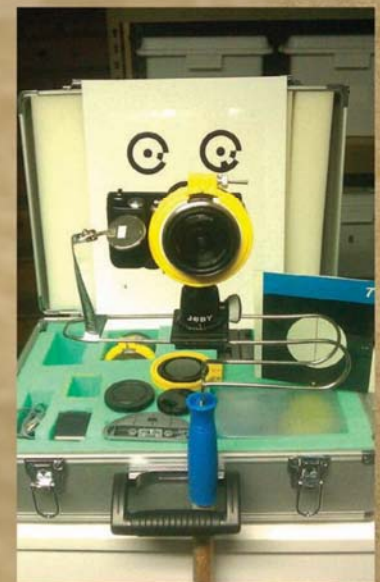
Figure 2. The camera in front of its case. Note the yellow lens clamp. Also note the small mirror that allows shutter actuation from below via infrared remote. Behind the camera is one of the 16 white calibration panels.

words, everything was done to make sure that all subsequent photography (calibration and site shots) used the same lens portion and parameters. The focusing ring on the camera was clamped with the help of a tight plastic ring against the lens housing so that it didn't move (see Figure 2). The camera was then calibrated with the help of 16 panels holding five target points each (a calibration field of 80 target points) which were placed on the ground in a tight formation (filling the lens field-of-view). Twelve photos were then taken of the target panels (three camera positions from four directions).

Figure 2 shows one of the ground control targets (blue strip #7). These targets were built so that the center of the target (white circle) was exactly above the small yellow arrow at the bottom of the target, and 0.20 feet above the ground. The vertical shift (+0.20') in the control elevation was taken into account during computations.

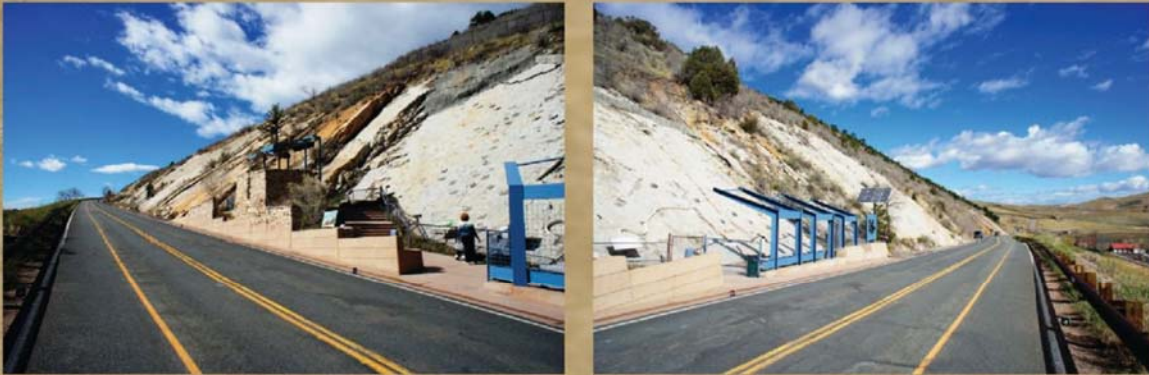
Figure 3. Collecting the control space photography. This consisted of taking photographs up and down the road (this Figure shows two of the shots) to create a controlled photogrammetric space along the road.

and vertical control space for the project, and the resulting adjusted photogrammetric block (for Phase 2) having an overall RMS of 0.01 pixels, and a largest ground control residual of 0.9 cm. Since this block included pass points up the side of the hill (utilizing natural features), block residuals were somewhat larger than expected. (Figure 3)

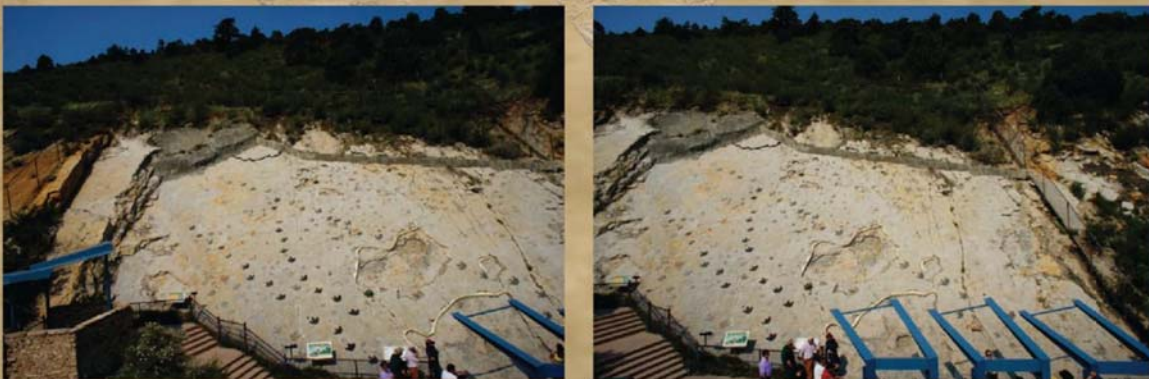
Figure 4. Transferring the control space up the slope.

Transferring control up the slope consisted of taking shots upslope from various points along the road (from the road straight up the hill), essentially to transfer and extend the control field along the road all across the track site (See Figure 4). Phase 3 photography lens axes were approximately parallel to each other and approximately horizontal.

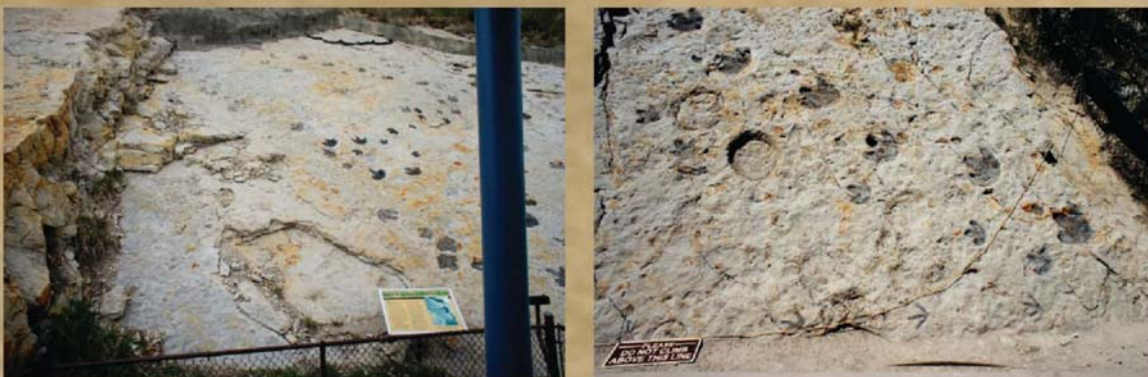
Figure 6. Taking detailed photography at various scales and overlaps.

Collecting detailed photography consisted of taking quite a few detail photos closer to the track surface and gradually incorporating them into the photogrammetric block. Given that limited computing power was used for this, it is estimated that about a hundred block adjustments were executed (See Figure 6).
