# Survey of Ely Bridge, Monticello, Iowa

Prepared by Harold Schuch, PE  
Lecturer at University of Colorado, Denver  
December 19, 2016

The purpose of this project was to assess the feasibility to restore the Ely Bridge in Monticello, Iowa, a structure listed in the National Register of Historic Places. The author was invited by the Department of Civil Engineering of the University of Colorado, Denver, to create a three-dimensional scaled wire frame of the bridge to be used in a finite-element stress analysis. This report describes the effort of creating this digital three-dimensional wire frame, using photogrammetric tools. This purpose does not create the need for a highly precise result for photogrammetry. It is estimated that this type of project only requires an overall accuracy of about  $\pm 4$  inches in terms of the position of details.

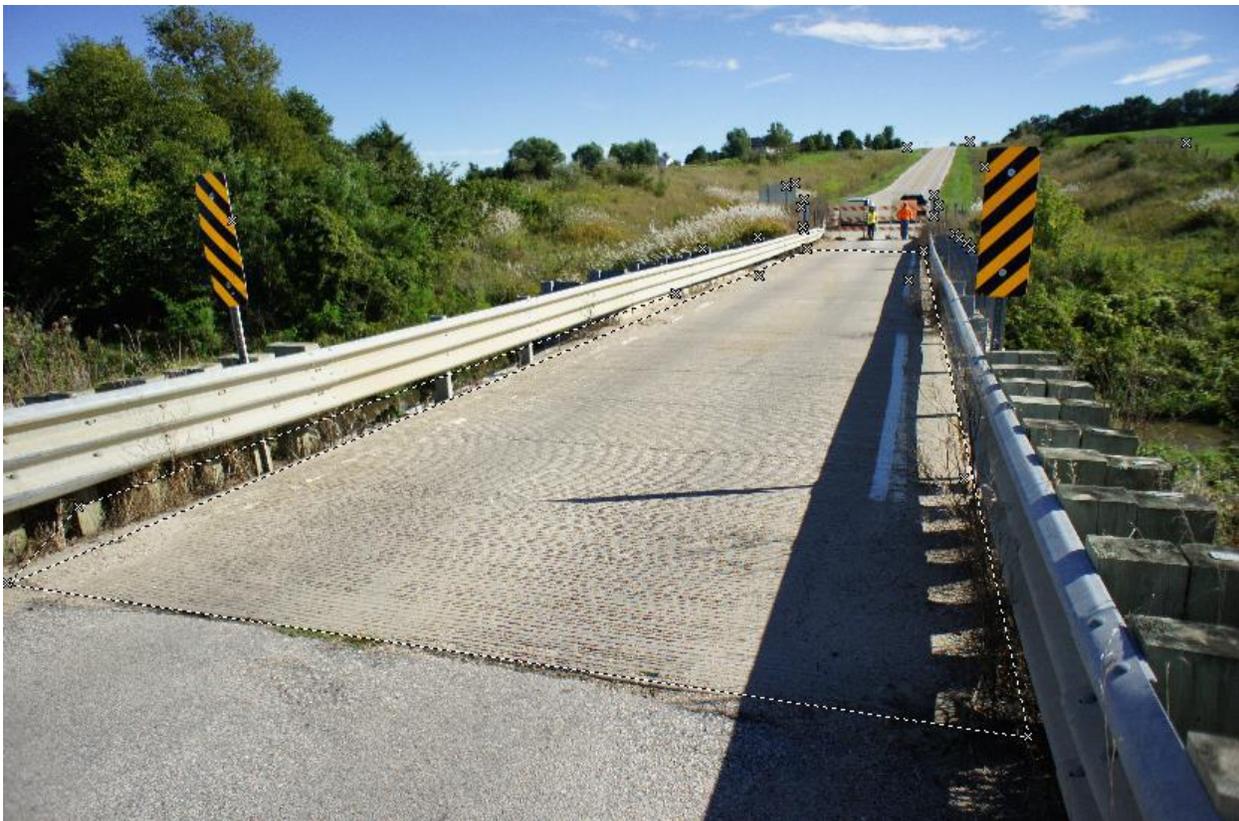
Of the 35 pictures that were taken, a selected 20 were used to digitize the bridge from various angles. In Figure 2, one can see the dashed line that represents the concrete slab.

*Figure 2 – One of the images used for scaling, leveling and digitization*

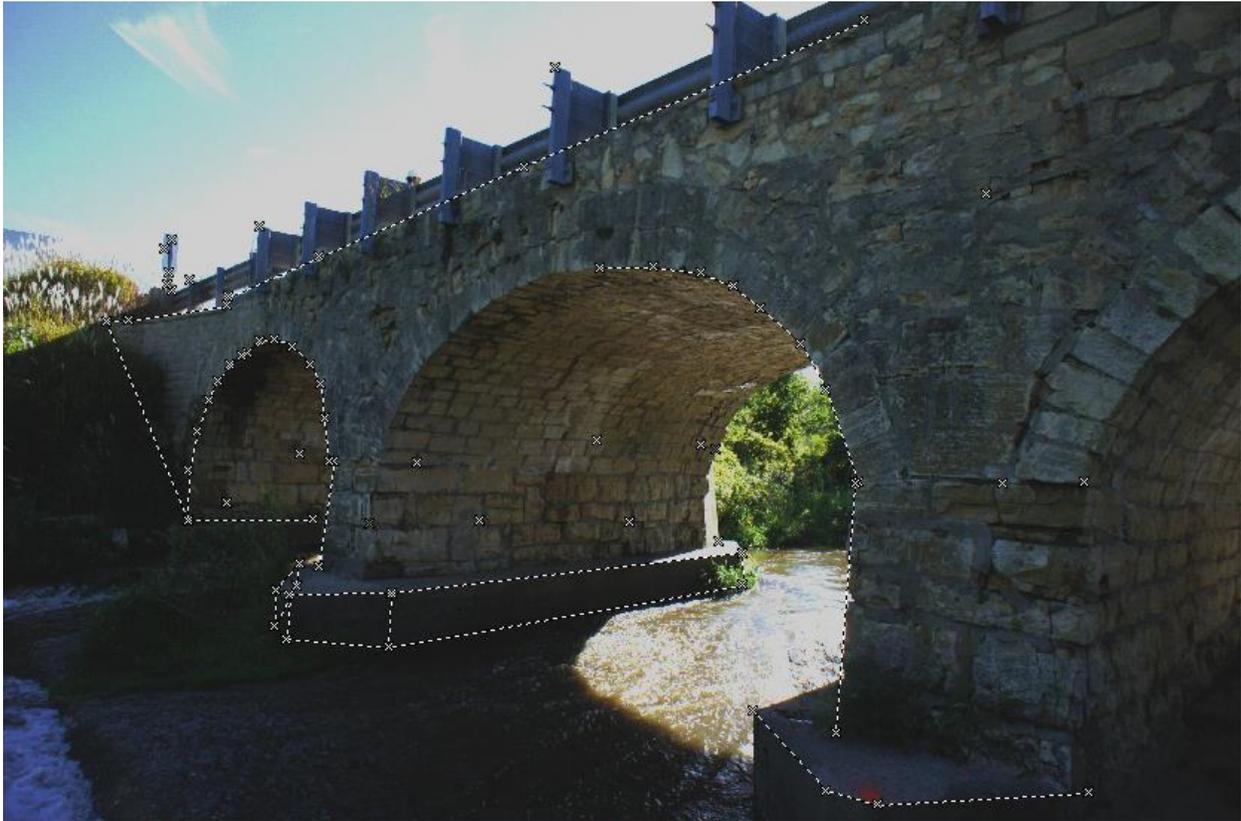
In Figure 3, some of the digitized detail is also shown. Note that some of the larger irregularities of the bridge stone were also captured.

*Figure 3 - One of the images used for digitizing the arches and other detail*
