*Using Photogrammetry
to Monitor
Materials Deterioration
and Structural Problems
on Historic Buildings*

*The Dorchester Heights
Monument:
A Case Study*

**U.S. Department of the Interior
National Park Service
Preservation Assistance Division**

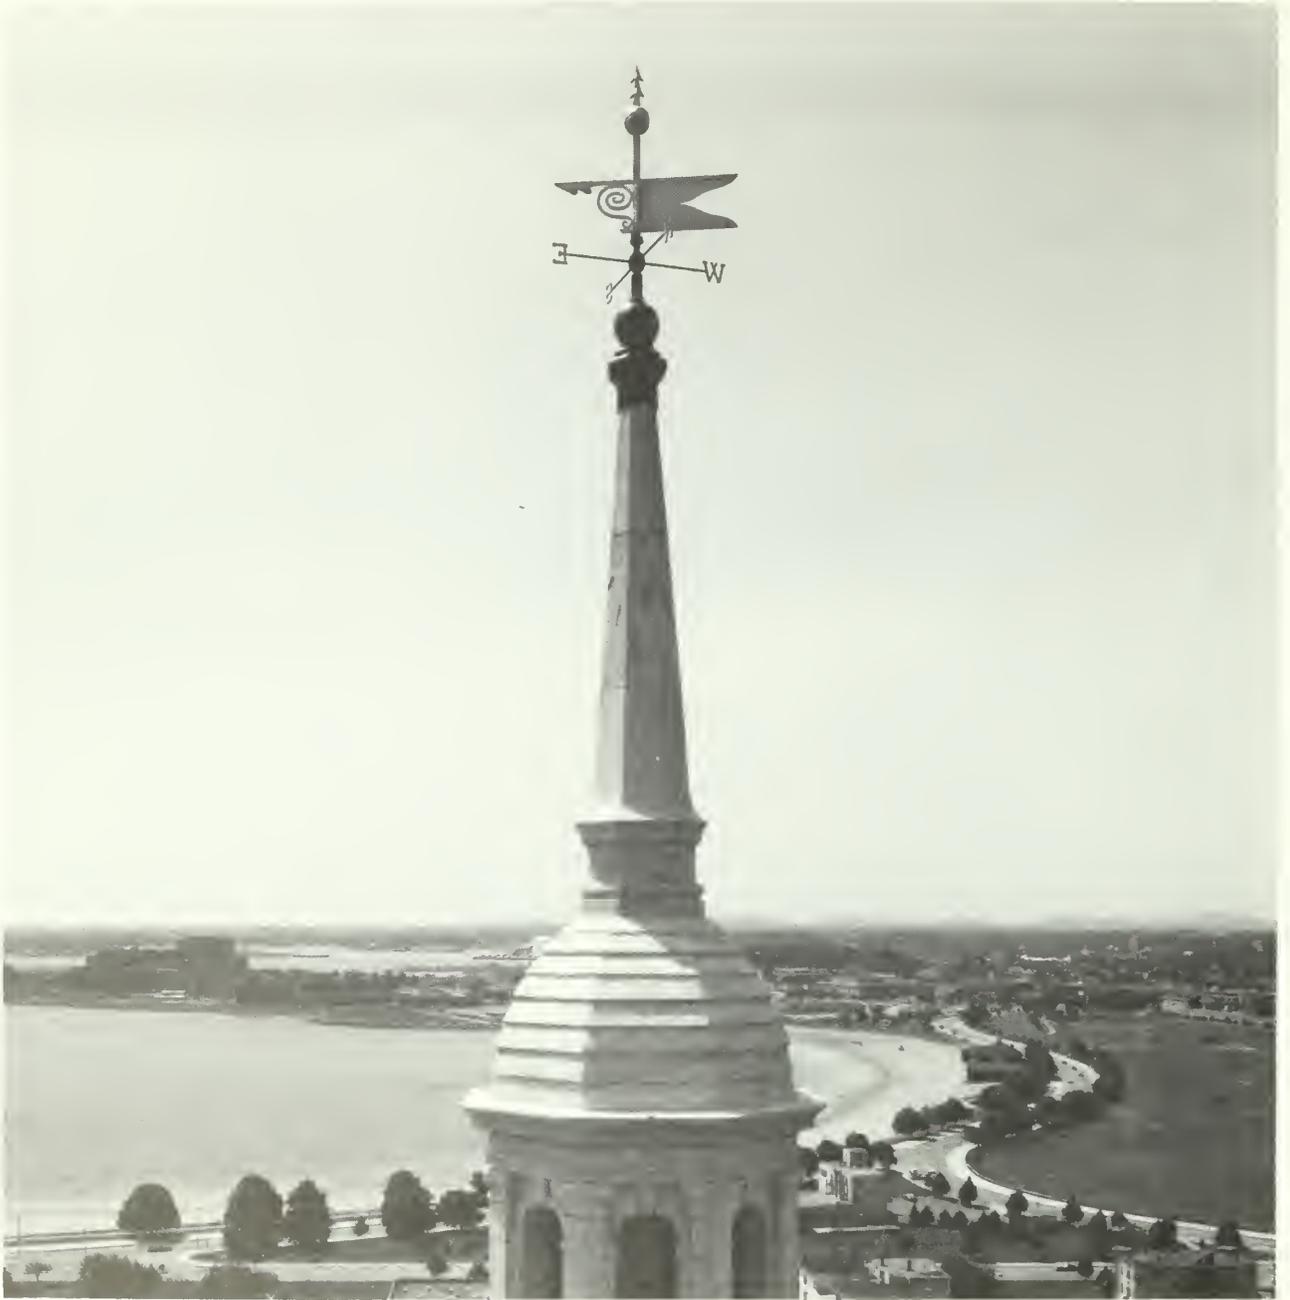
Figure 3F

The materials deterioration and structural problems recorded here can be used to monitor the condition of the structure over the course of time and to develop treatment strategies. (The photograph of the spire end weathervane, figure 3F, was not annotated.)
