# Using a single photo to determine the length and width of a road hazard. Keystone Bay, Keweenaw County, Michigan

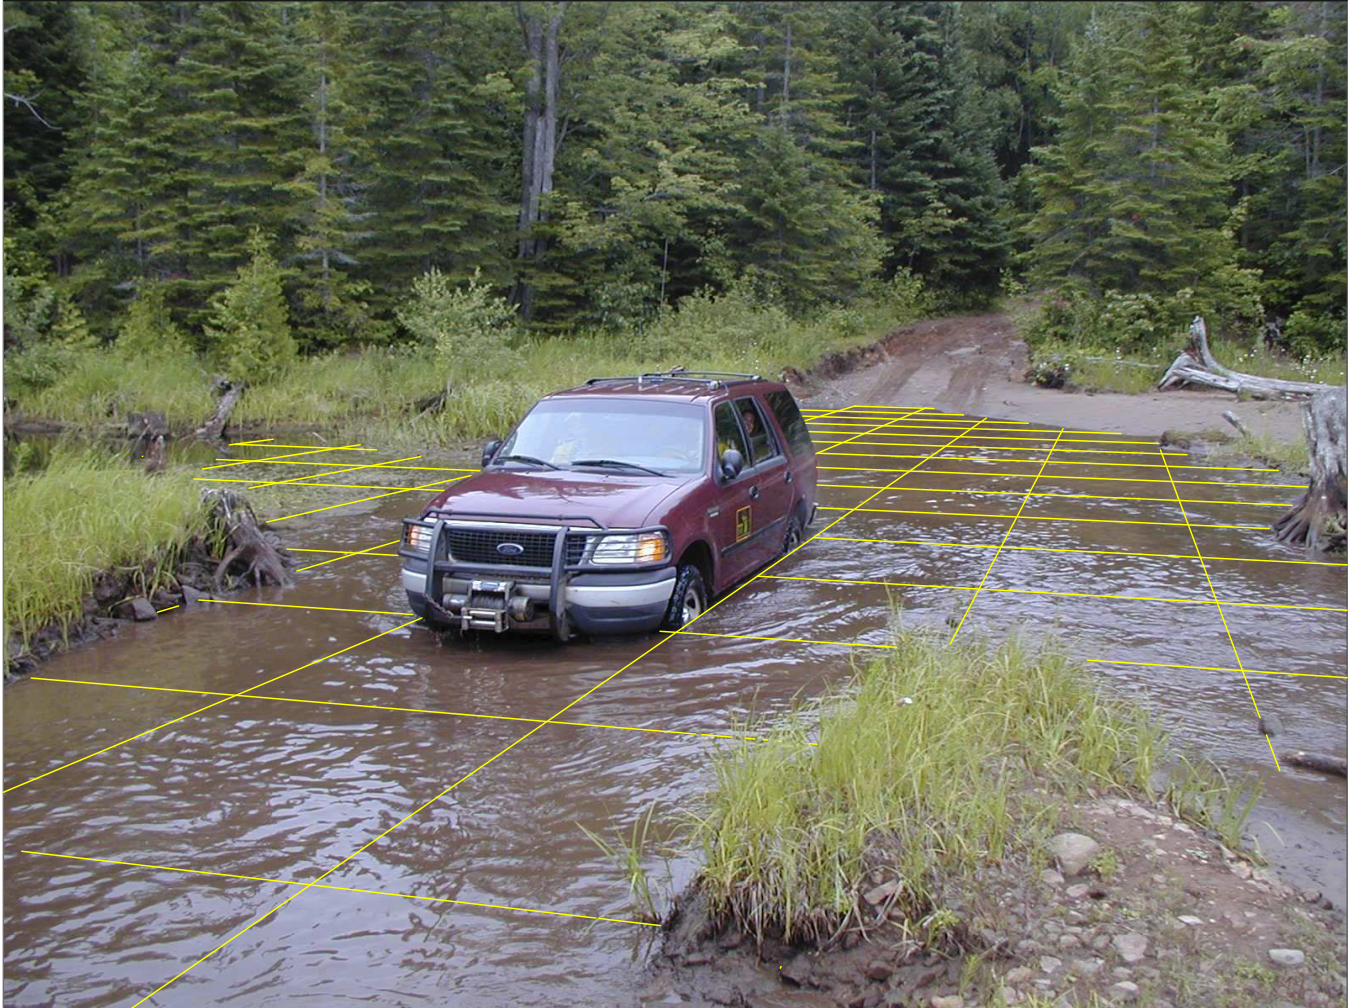
Having only a single photo available, convergent photogrammetric techniques were not applicable. In this instance, dimensional analysis through perspective, using the traditional horizon line-vanishing point method, allowed the determination of the size of a hazard flooding on this remote road in northern Keweenaw County.

The analysis was done 3 years after the photo was taken in 2006. The vehicle in the photo, still in the fleet in 2009, was used for scale in this project.

The projected lines form a 6 ft. x 6 ft. grid. The submerged area extends to approximately 48 feet in width and 90' in length.
