NASA/TP-98-201793

Photogrammetric Assessment of the Hubble Space Telescope Solar Arrays During the Second Servicing Mission

Final Report

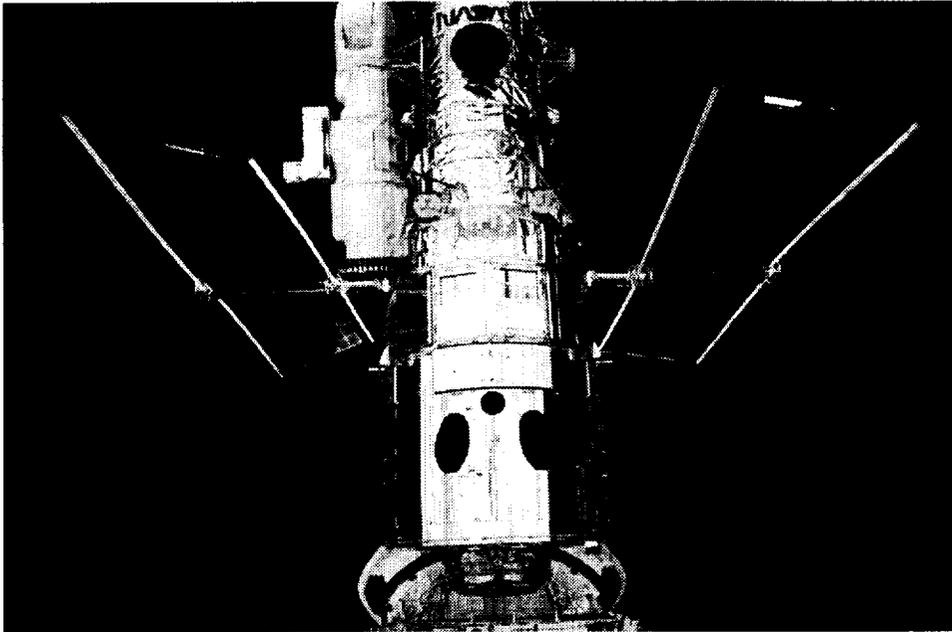
Figure 1.1 The Hubble Space Telescope.

The Hubble Space Telescope (HST, Fig. 1.1) was launched on the Space Shuttle in April 1990. The HST is the first space-borne observatory designed to be serviced on orbit and is intended to be serviced by the Shuttle every 2-3 years. During the first servicing mission (SM-1) in December 1993, the two solar arrays that power the telescope were replaced. The new arrays, which were designed and built by British Aerospace, were a semi-rigid design, deployable from a central cassette, with structural rigidity provided by two interlocking metal bands called bistems. The arrays were designed to be able to be unfurled and furled multiple times to facilitate servicing and reboost of the HST. Figure 1.2 shows details of the HST solar array.

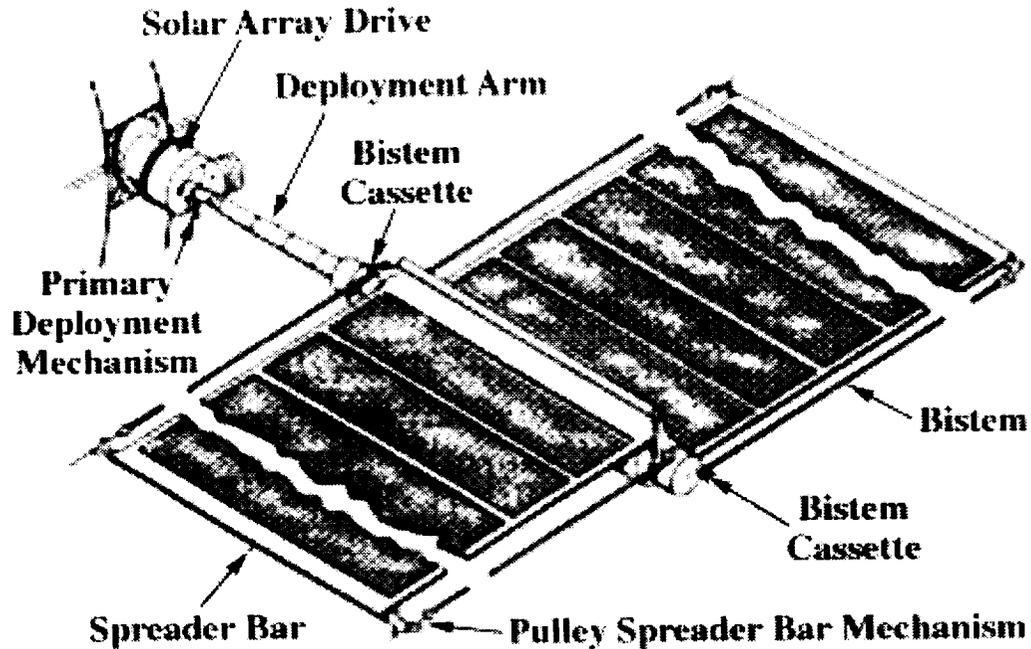
Figure 1.2 HST solar array details.

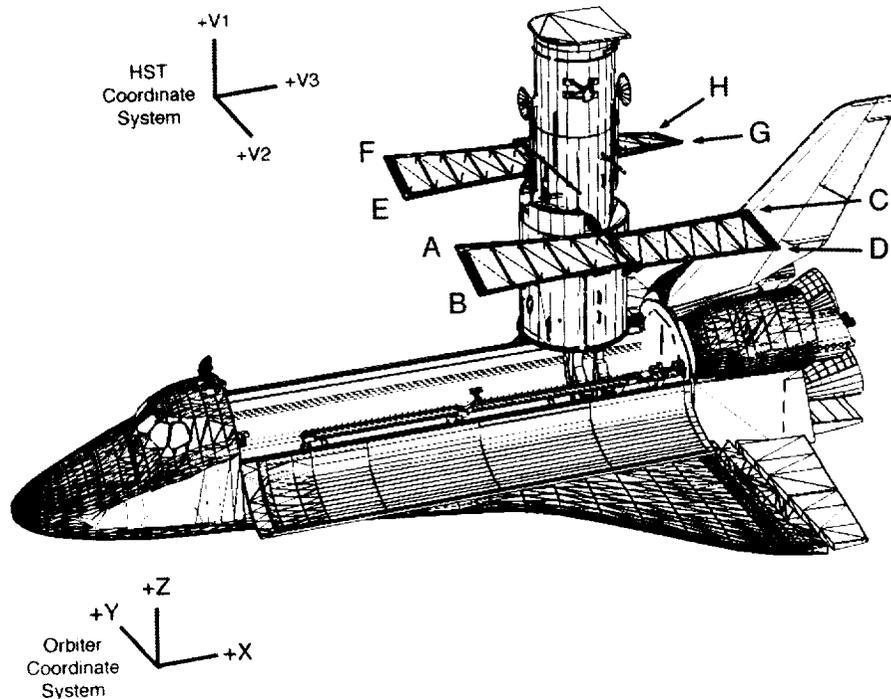
Figure 3.2 *Illustration of HST in Shuttle payload bay, demonstrating solar array tips and Shuttle and HST coordinate systems.*

The objective of the static twist analysis was, for specified times, to determine the positions of tips of the solar arrays in the Hubble coordinate system. (Figure 3.2 is an illustration of the HST in the Shuttle PLB, the tips of the solar arrays, and the HST and Shuttle coordinate systems.) The Shuttle PLB cameras provided imagery for determining the 3D position of each array tip, using a two-camera phototheodolite technique. This section describes the phototheodolite method, the implementation of the phototheodolite technique to the array tip location task, the method for estimation of the accuracy of the phototheodolite solutions, and the validation test of the methodology.

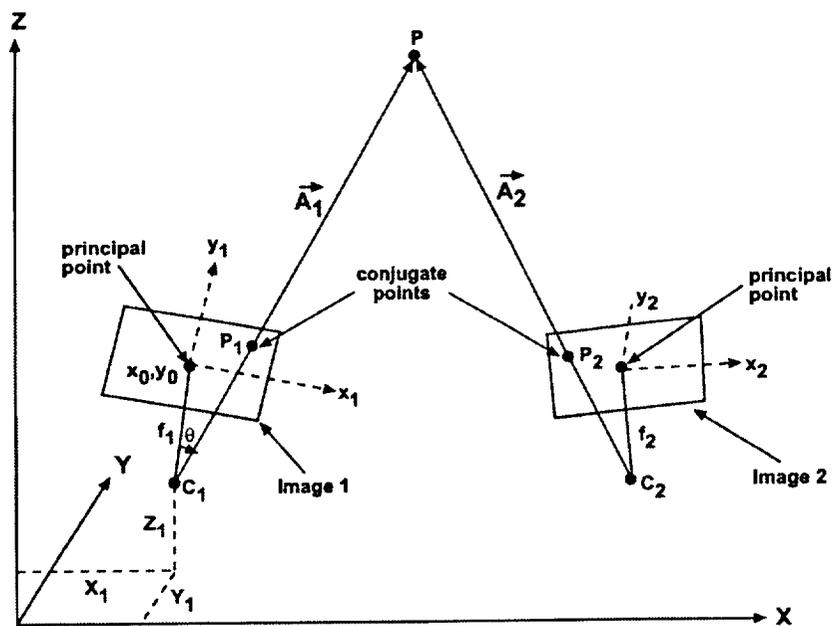
Figure 3.3 Elements of two-camera photogrammetric triangulation based on intersection of convergent rays in space.

Once the interior and exterior orientations of the two cameras are determined, the intersections of the two vector rays to the object point can be determined from the image measurements. These are, of course, not trivial measurements or calculations, especially for non-metric cameras such as the Shuttle video cameras. All of the parameters, including determinations of the effective focal length (EFL) of the zoom lens and lens distortions, contribute to the vectors' failure to intersect. A common solution to the issue of the two vectors' failure to intersect at a point is to calculate the shortest distance miss of the two vectors and take the midpoint as the position of the object point of interest. Solutions that take advantage of having multiple images of the object of interest employ methods of photogrammetry called "bundle adjustments" to determine the point of intersection. The method of bundle adjustments was used in the post-mission analyses and is described in Section 6.1.

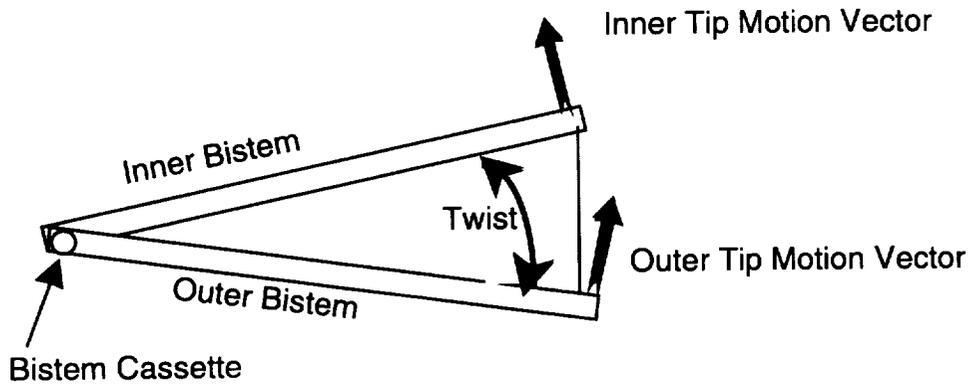
Figure 3.4 Diagram illustrating the effect of solar array twist on the direction assumed for solar array motion.

The twist in the solar arrays created a problem in defining a common plane to which the motion of both tips could be assumed perpendicular. The twist caused separate planes for each tip to be defined. (See Figure 3.4.) Each plane was defined by three points: the solar array tip, and the inner and outer edges of the bistem cassette for that array. The inner and outer bistem cassette edge coordinates were determined by using the fixed HST coordinates of those two points, and transforming them into the Shuttle coordinate system using the current FSS rotation value. However, because of the twist, the radii of the two tips are not aligned and hence the direction of motion of each tip is different.

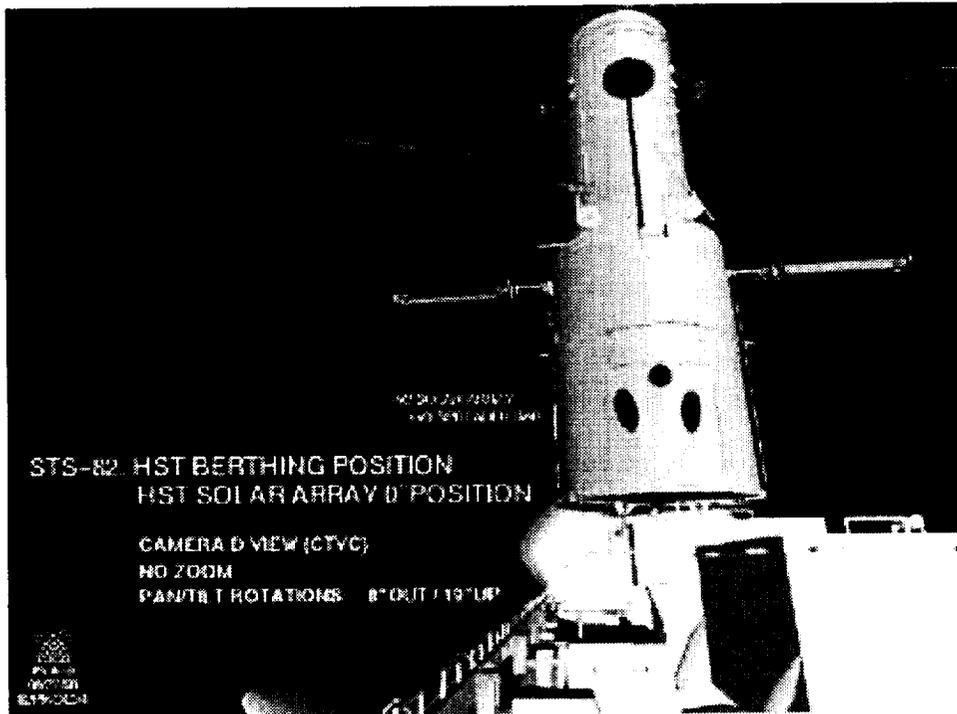
Figure 4.2 Representative CAD view used in image acquisition planning.

The viewing analysis identified the cameras and camera settings to use for the measurement of solar array motion. The camera views were simulated from JSC GRAF CAD drawings. Figure 4.2 shows a representative simulated view.

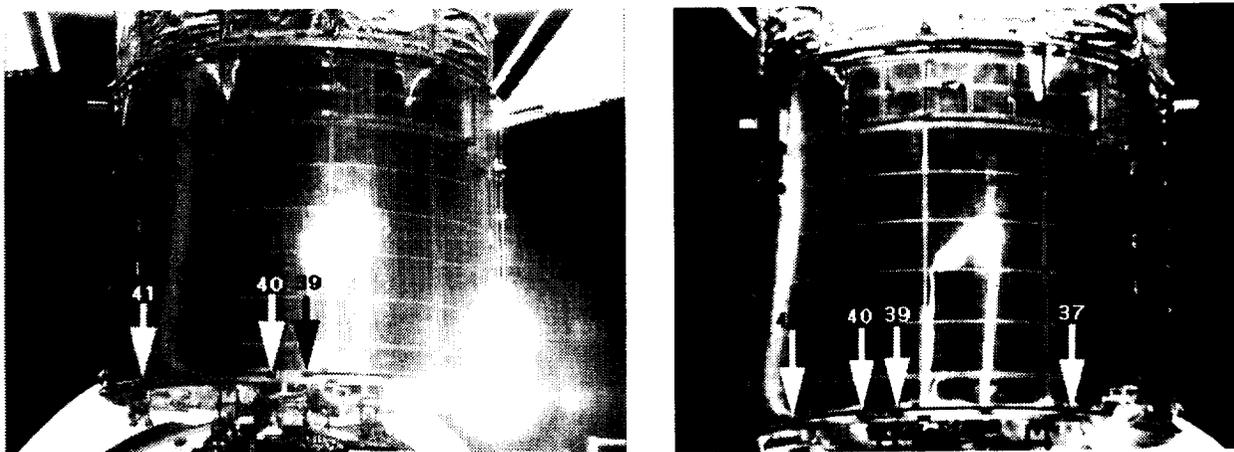
Figure 5.2 Reference points on rotation images.

2. Digitize, label, and correct aspect ratio of rotation image.
3. Select reference points from rotation image. (Note: Rotation calculations were performed only once per day.) (See Figure 5.2.)

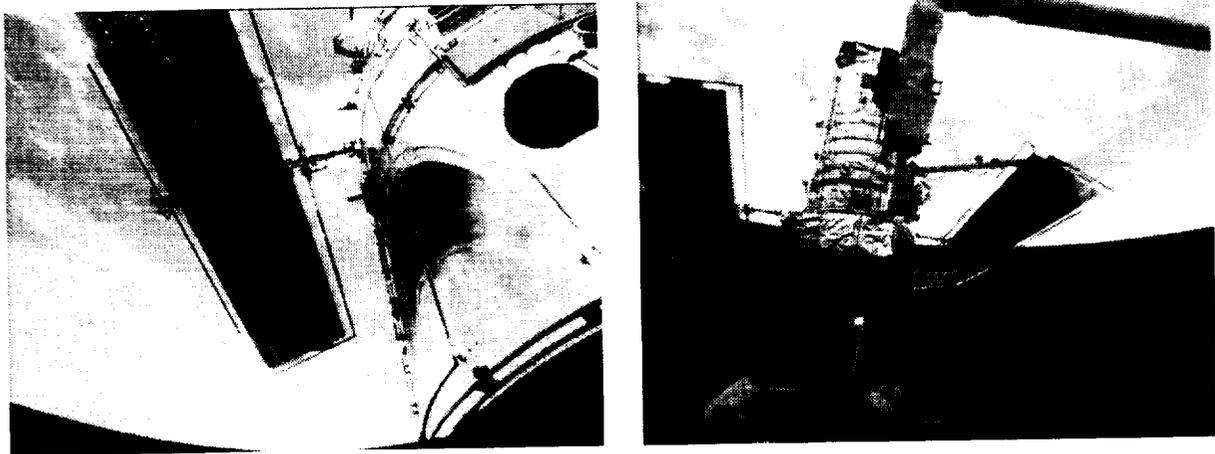
Figure 5.4 HST full FOV images from cameras B (left) and D (right).

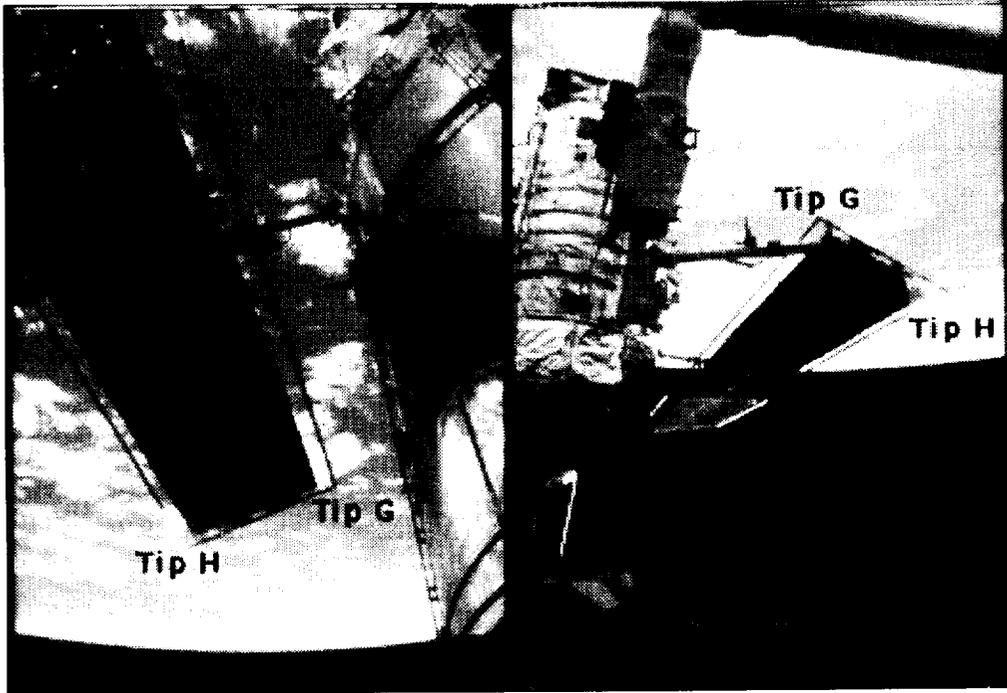
Figure 5.6 Multiplexed images of HST solar array tips.

8. Enter reference point ID numbers on data entry sheet.
9. Select solar array tip image coordinates from multiplexed views. (See Figure 5.6.)
10. Enter reference point image coordinates into user input spreadsheet.

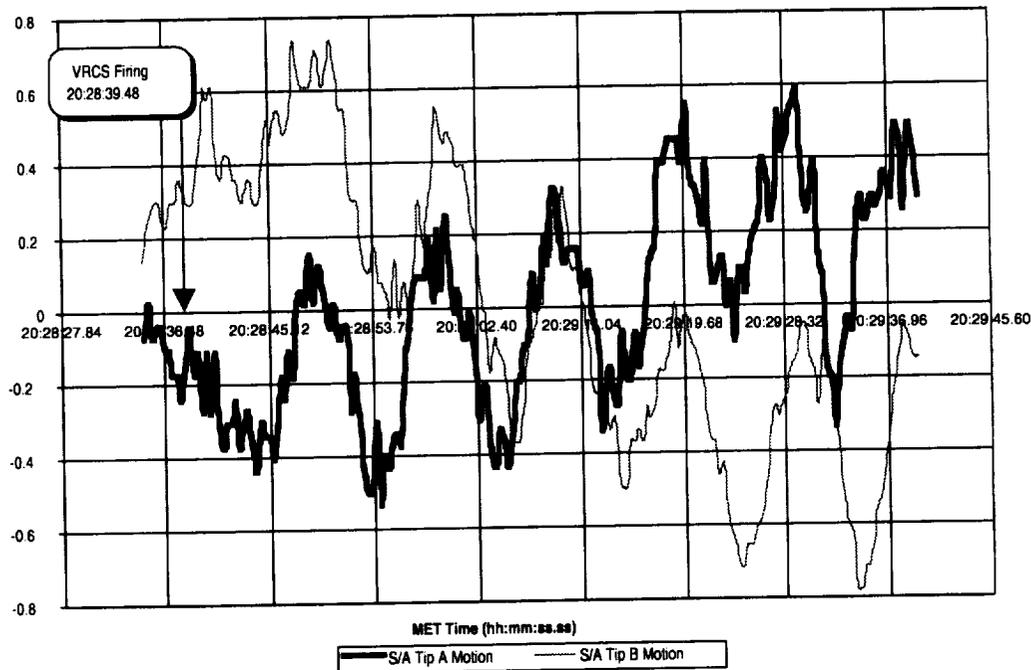
Figure 5.11 Displacement of tips A and B during VRCS firing on Flight Day 3.

Based on the solar array motion analysis procedures defined pre-mission, the video frames were sampled at a rate of 3 frames per second (3 Hz), for a total of 180 frames analyzed. The results showed a maximum peak-to-peak displacement of approximately 0.7 inches for tip B and 0.6 inches for tip A, with a frequency of approximately 0.1 Hz for both tips (see Figure 5.11). The displacements and the frequency were as expected, based on HST FS&S Project structural dynamics models. The motion continued for approximately 3 minutes after the analysis interval and no apparent damping was noted.

The plot of tip displacement vs. time depicted in Figure 5.11 shows an apparent discrepancy in tracking the tips, since the displacement for tip A crosses that of tip B. Post-mission, it was determined that this effect was caused by a shift in the line-tracking intersection point for both tips during the tracking process. The line intersection that defines the tip position migrated from one edge of the spreader bar to the other edge causing an apparent translational motion. This problem was caused by variable lighting conditions that changed the appearance of the spreader bar edges and caused the fitted line to move from one side of the spreader bar to the other. To correct for this problem and to analyze the motion over a longer period, the solar array motion was re-analyzed after the mission using improved motion analysis methods. See Section 6.2.4 for the results of the post-mission analyses.

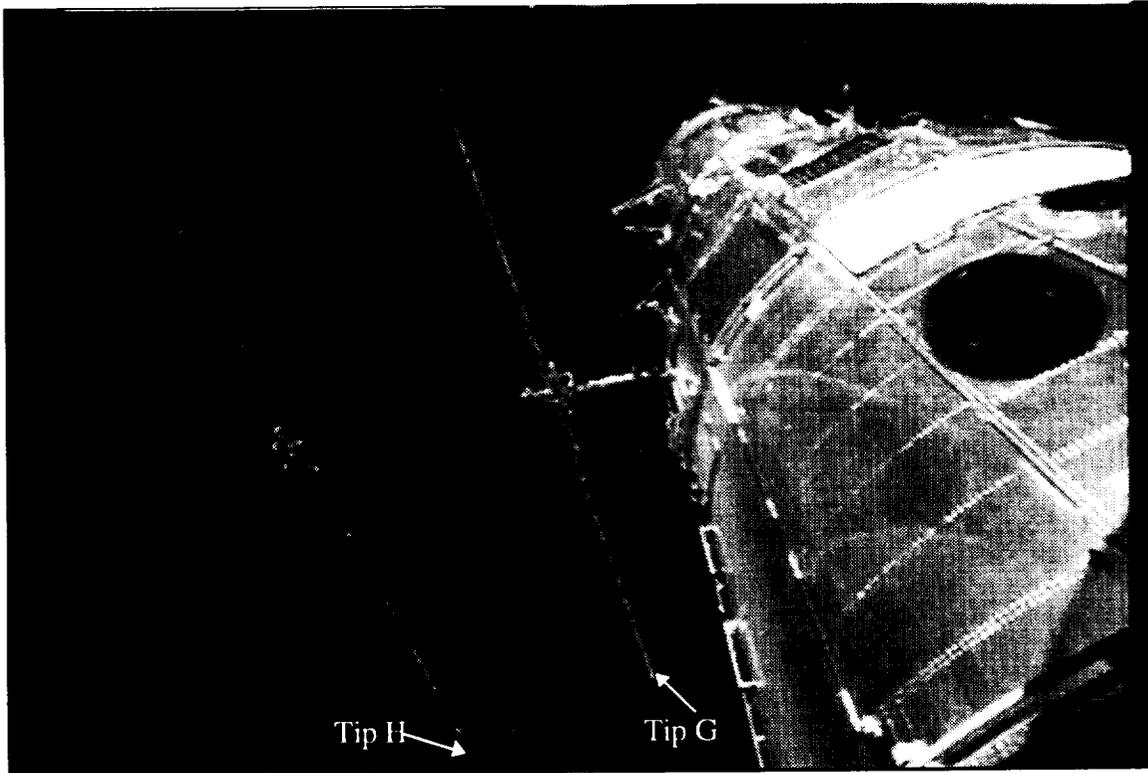
Figure 5.12 View of -V2 solar array tips G & H from camera B during airlock depressurization-induced solar array motion.

A video sequence of approximately 1 minute (UTC 049:03:12:32 to 049:03:13:32), taken from camera B of the -V2 forward solar array tips G & H, was analyzed. Figure 5.12 is a representative view of the solar array during the airlock depressurization event. Because of the low contrast of the spreader bar in the image, the automated edge detection and line-tracking analysis procedure was not used. Therefore, all data points were extracted manually. To minimize point selection bias, the data points were independently selected by two analysts, whose results were in very good agreement (± 1 pixel). The motion analysis was completed in approximately 5 hours. The analysis sample rate was 3 frames per second, for a total of 161 frames analyzed.

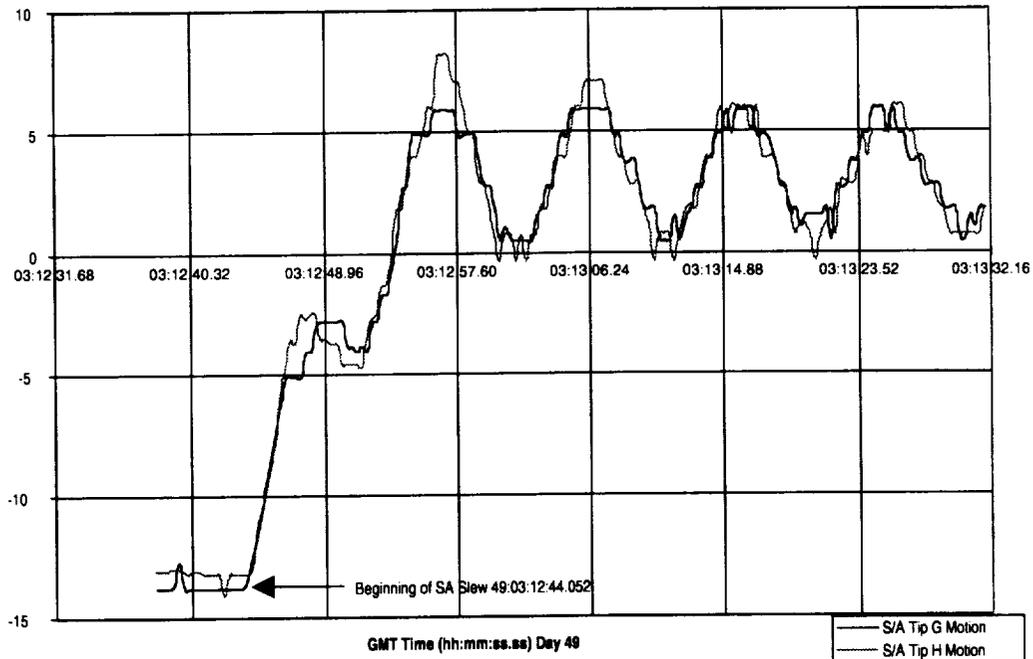
Figure 5.13 Displacement of tips G and H during airlock depressurization on Flight Day 8.

The airlock depressurization-induced solar array motion was re-analyzed after the mission using improved motion analysis methods. See Section 6.2.6 for the results of the post-mission airlock depressurization analysis.

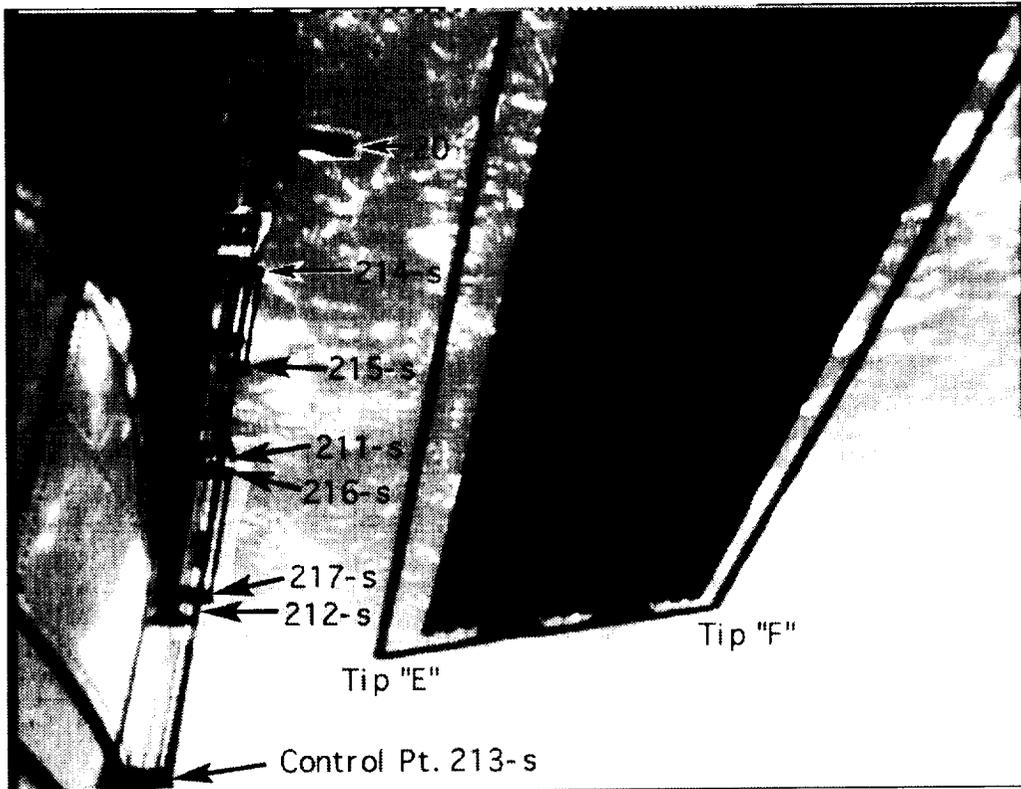
Figure 6.1 Image of tips E and F taken from camera C, showing the linear configuration of control points.

Note that the control point numbers with the attached post-script "-s" designate control points that were originally located at the handrail attach points, but were extended 3.003 inches radically outward from the HST "V1" axis to produce a control point on the top surface of the handrail.

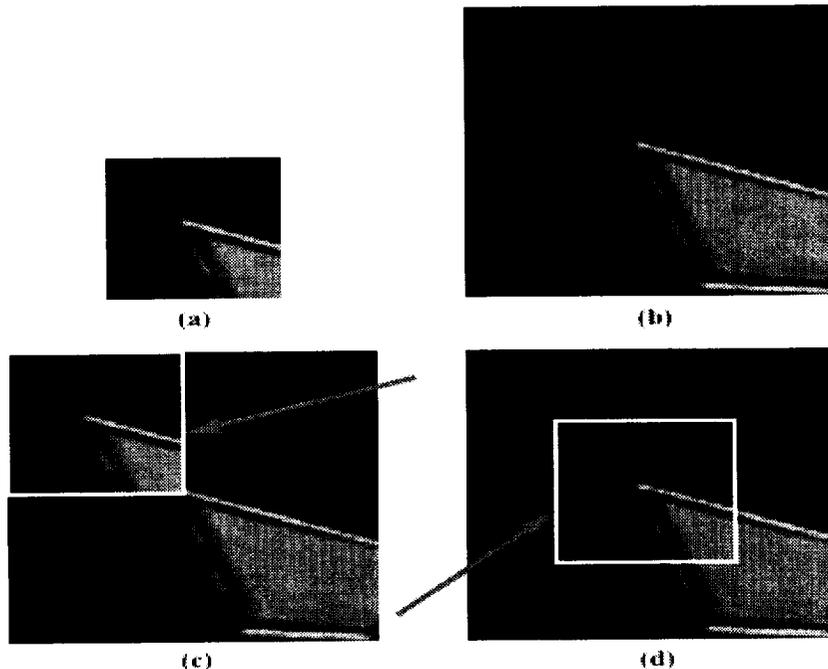
Figure 6.2 Point tracking method applied to tracking an HST solar array tip.

Figure 6.2 illustrates the point-tracking method as it was applied to the HST solar array motion-tracking task. The search pattern surrounding the array tip is shown in (a). The window in the next video frame to search for the pattern is shown in (b). The pattern passing over the window is shown in (c). Correlation values are computed for each pixel that the pattern passes over and (d) shows the pattern matching over the target. The correlation should be the highest at this pixel position (i.e., at the center of the white box). The coordinates of this position are saved and the same steps are repeated for the next frame.

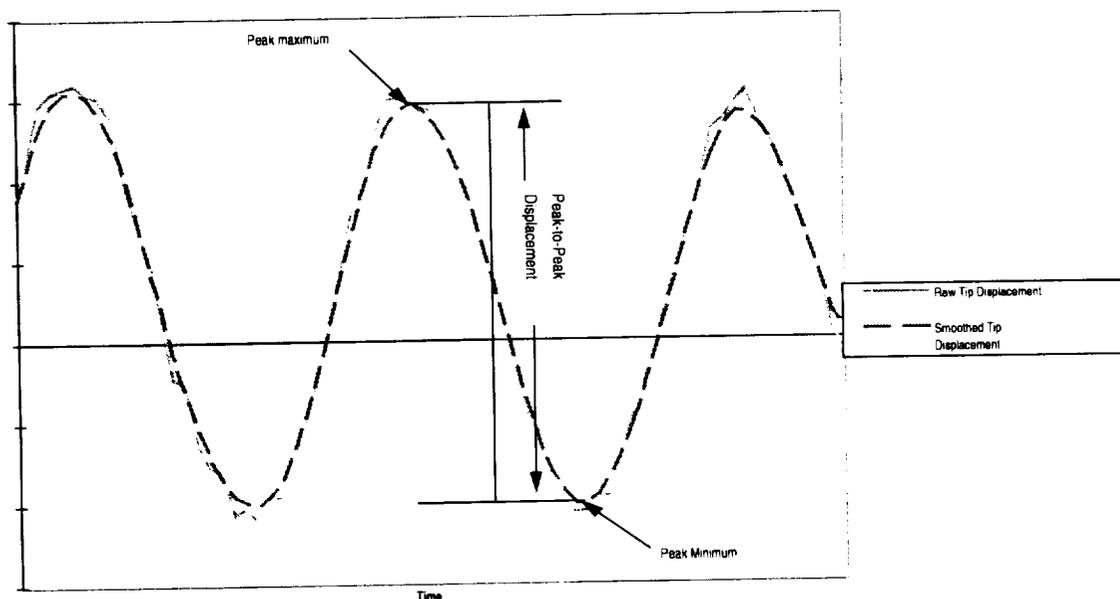
Figure 6.3 Illustration of maximum peak-to-peak displacement of solar array tips.

3. The peak-to-peak displacements were obtained from the smoothed displacement data. The peak-to-peak displacement was calculated by finding the values for the peak maximum and peak minimums for the selected peak-to-peak displacement. The difference in the peak maximum and peak minimum values was then used as the peak-to-peak displacement.

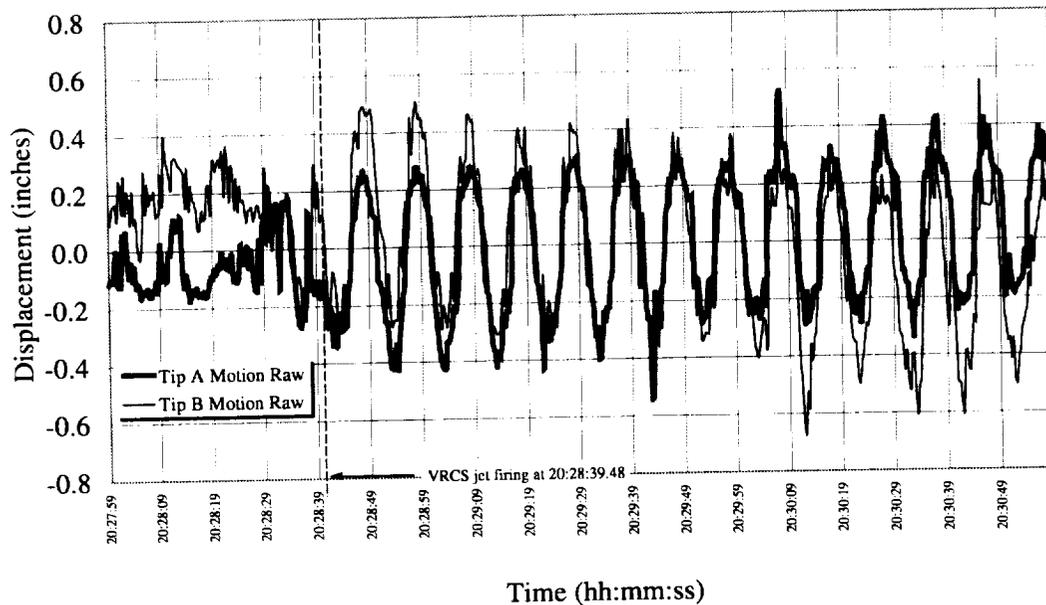
Figure 6.4 Solar array tip displacement during the VRCS-induced solar array motion (Flight Day 3).

Figure 6-4 presents a plot of the array displacement as a function of time. This plot represents a smoothing of the original data using a five-point moving average filter, and Appendix G presents the original unsmoothed tip displacement plot. Filtering of the data was necessary to remove high-frequency noise in the motion tracking. This noise was caused by subtle lighting variations in the scene. Note that, unlike the analysis performed during the mission, the solar array tips did not lose tracking and the inboard (A) and outboard (B) tips tracked together.

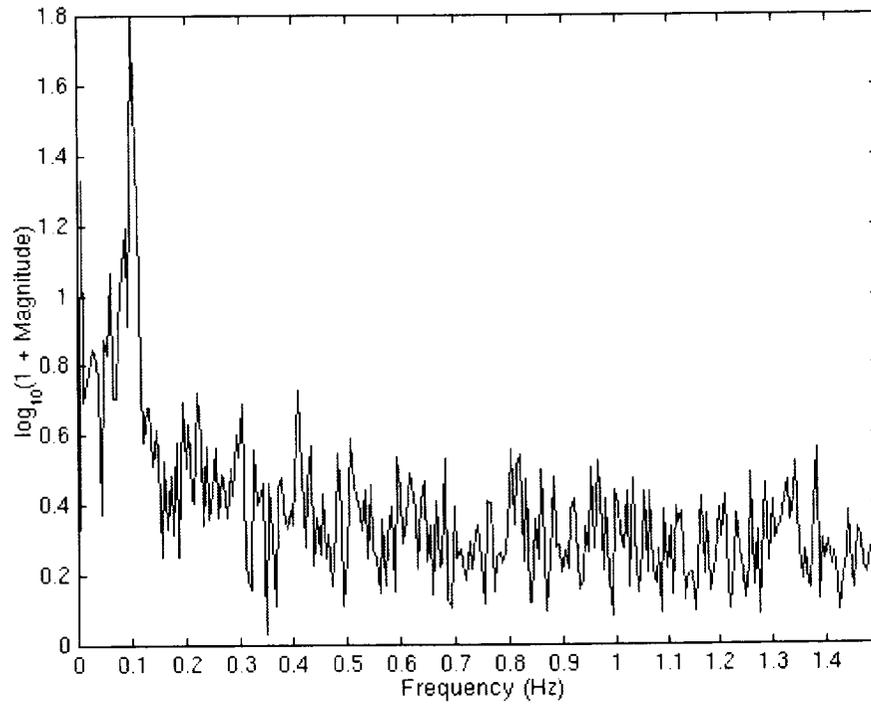
Figure 6.5 *Frequency plot for tip A from VRCS-induced motion.*

The dominant frequencies are revealed in the plots of the log magnitude of the frequency response as a function of frequency for each tip. Figures 6.5 and 6.6 show plots for tips A and B. The dominant frequency of the array tip displacements is shown (large magnitudes) to be 0.1 Hz for both tips, which was the same frequency measured during the mission.

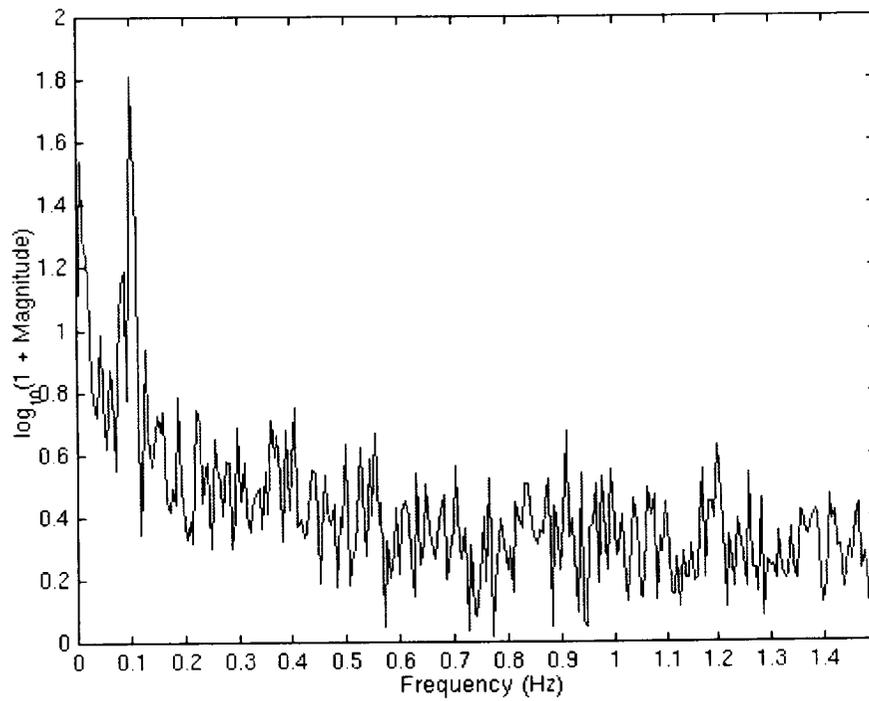
Figure 6.6 *Frequency plot for tip B from VRCS-induced motion.*

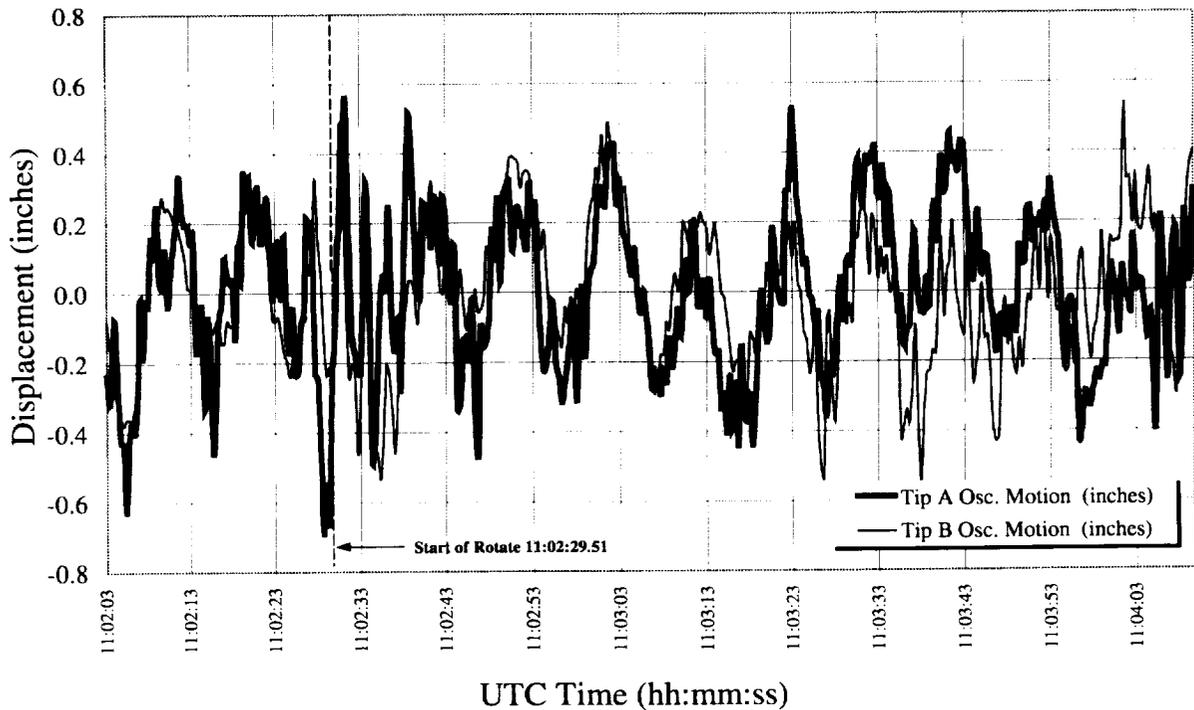
Figure 6.9 Solar array tip displacement during start of rotate event (Flight Day 5).

An approximately 2-minute video sequence showing the beginning of HST rotation on Flight Day 8 was analyzed. Camera B was used to image tips A (inboard) and B (outboard) during the start of rotation. The video sequence that was analyzed began at 11:02:02.85 UTC, which was just before the beginning of rotation, and ended at 11:04:09.51 UTC. Tip A was tracked using the line-tracking method because the point-tracking method could not remain fixed on the tip due to the background pattern change from the blackness of space to the blue/white of the Earth. The background for tip B did not change, and tip B was tracked with the point-tracking method. Tip A had a maximum peak-to-peak displacement of 0.62 ± 0.07 inches at 11:03:02.18 UTC, and tip B had a maximum peak-to-peak displacement of 0.64 ± 0.07 inches at 11:03:01.51 UTC. Both tips had a dominant frequency of approximately 0.1 Hz. Figure 6.9 shows the plot of the oscillatory displacement of the solar array tips as a function of time. The plot in Figure 6.9 represents a smoothing of the original data using a five-point moving average filter. Filtering of the data was necessary to remove high frequency noise in the motion tracking. Appendix G contains the raw, unsmoothed, displacement plot and the translational motion and frequency plots.

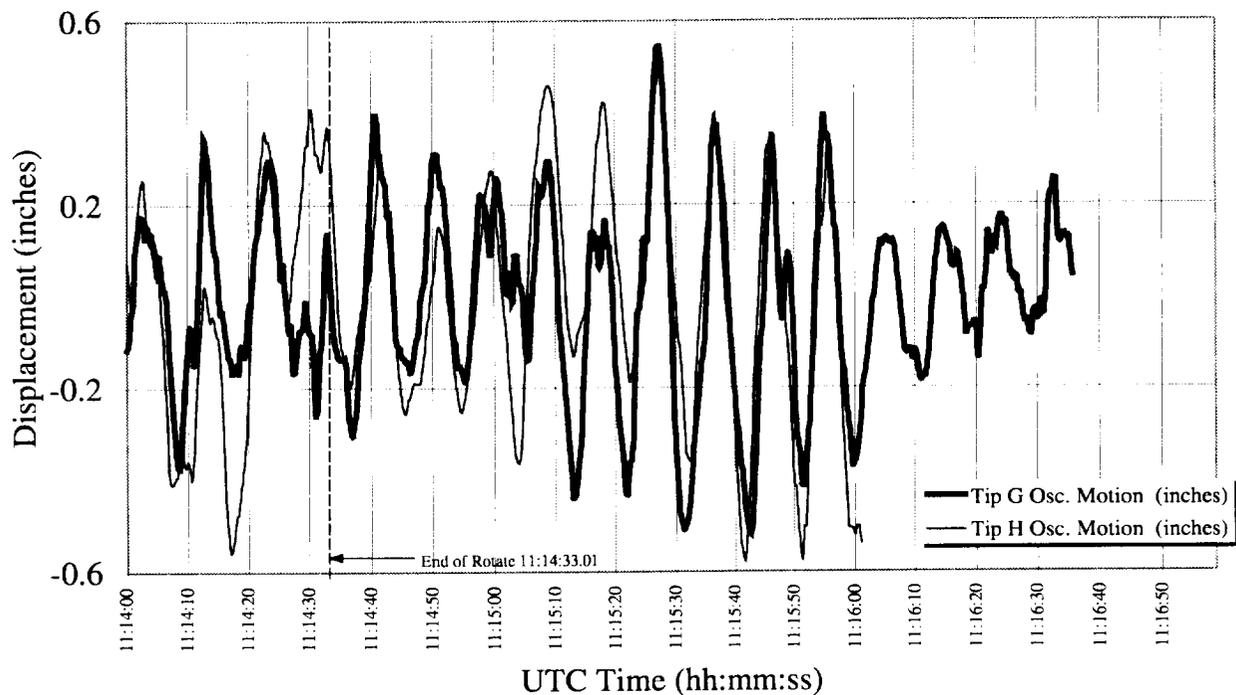
Figure 6.10 Solar array tip displacement during end of rotate event (Flight Day 5).

An approximately 2.5-minute video sequence showing the end of HST rotation on Flight Day 8 was analyzed. Camera B was used to image tips G (inboard) and H (outboard) during the end of rotation. The video sequence began at 11:14:00 UTC, which was just before the end of rotation, and ended at 11:16:35 UTC. Tip G had a maximum peak-to-peak displacement of 1.05 ± 0.14 inches at time 11:15:29.01 UTC with a dominant frequency of 0.1 Hz. Tip H had a maximum peak-to-peak displacement of 0.97 ± 0.11 inches at time 11:15:38.35 UTC with a dominant frequency of 0.1 Hz. Both tips were tracked using the point-tracking method. Figure 6.10 shows the plot of the displacement of the solar array tips as a function of time. Filtering of the data was necessary to remove high-frequency noise in the motion tracking. Appendix G contains the raw displacement plot and the translational motion and frequency plots.

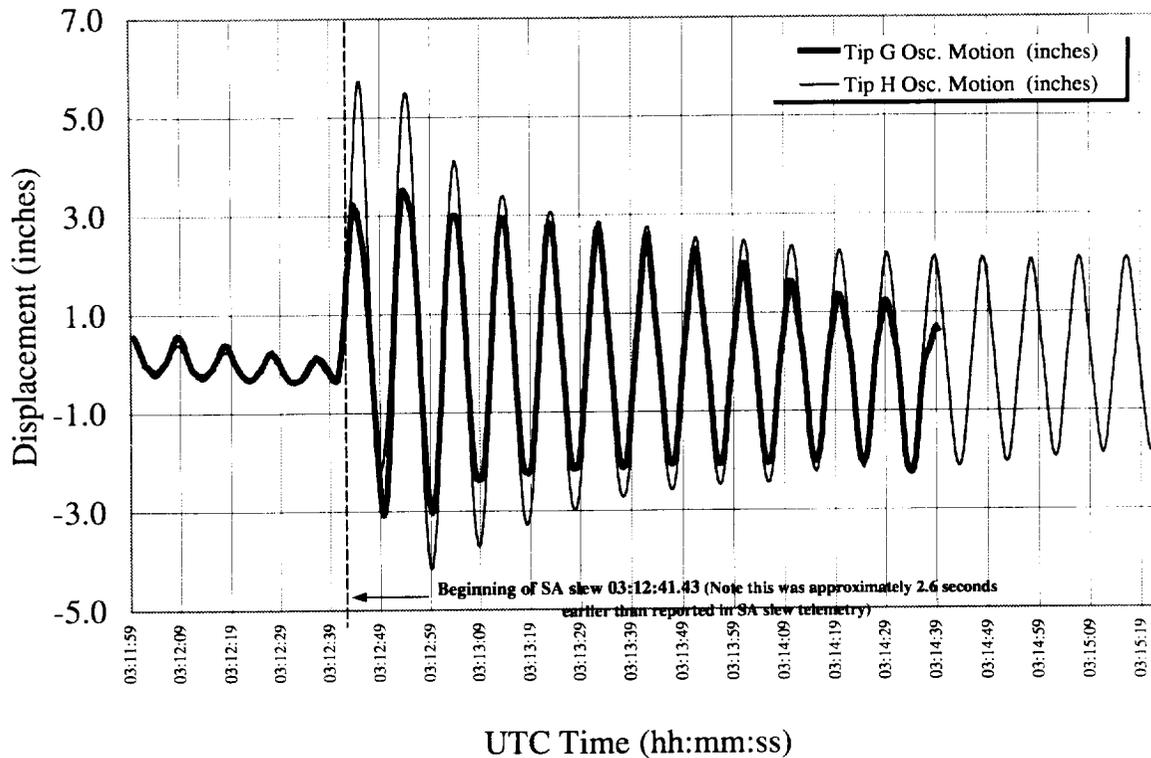
Figure 6.11 Solar array tip displacements during airlock depressurization (Flight Day 8).

Figure 6.11 gives the plots of the displacement of the solar array tips and Appendix G contains plots of the displacement before the slew of the array was subtracted out. The plot in Figure 6.11 represents a smoothing of the original data using the five-point moving average filter. For the airlock-depressurization solar array displacement plot, the data had very little noise and smoothing was minimal. The plots of the raw tip displacements and frequency analyses are also in Appendix G. The maximum peak-to-peak displacement was 9.66 ± 0.41 inches at time 03:12:53.77 UTC for tip H and 6.53 ± 0.37 inches at time 03:12:53.43 UTC for tip G. The dominant frequency was approximately 0.1 Hz. Note that the background or base array motion was very evident before the airlock depressurization-induced slew. The peak-to-peak displacement of this background motion was approximately 0.2 inches and the frequency was 0.1 Hz. A clear damping of the tip displacement was observed for both tips. The displacement for tip G was measured for a shorter timeframe (170 seconds) than tip H (210 seconds), because a shadow passed over tip G, changing the background, and causing a loss of tracking. When the shadow passed over tip G, the change in lighting altered the pattern of pixel intensities surrounding the tip so much that the search pattern could no longer recognize the tip.

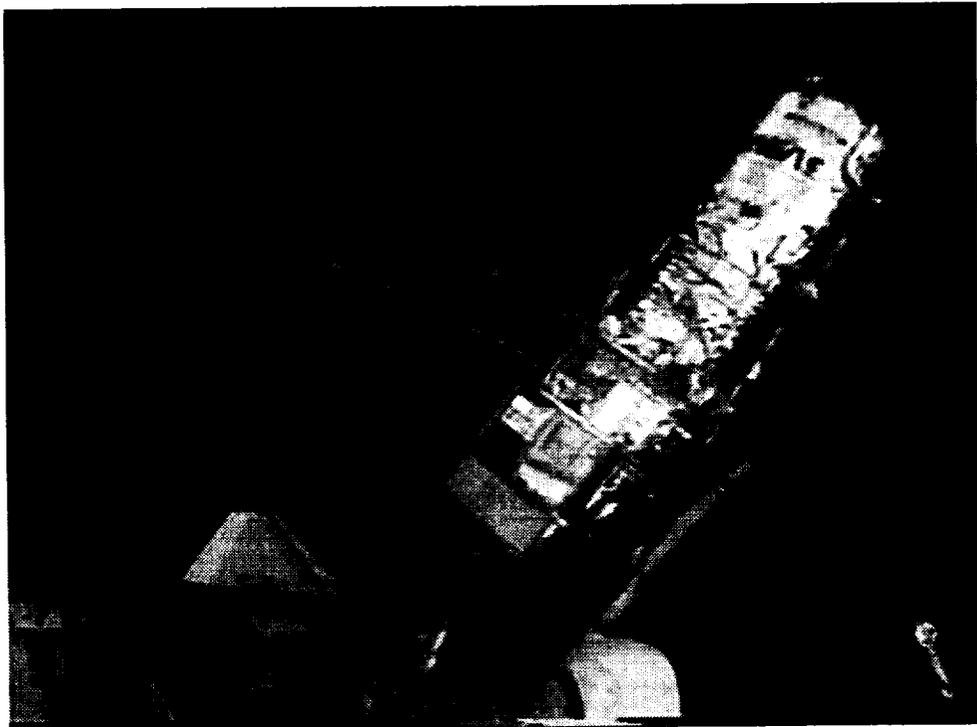
Figure 6.13 View of -V2 solar array tips E and F from the RMS elbow camera during end of pivot.

Like the analysis of solar array motion during the rotation on Flight Day 5, the analysis of the array motion during the HST pivot event on Flight Day 8 was a two-step process. First, the array motion was analyzed from just before the beginning of pivot until several minutes after pivot. The video was analyzed just before the pivot so that a sudden change in the plot of array displacement vs. time would indicate the exact time that pivot began. Second, the array motion was analyzed from just before the end of pivot until several minutes after the end of the pivot event. For the conclusion of the pivot, the video was analyzed just before the end of pivot so that the sudden change in the array displacement plot would indicate the exact time that pivot ended.

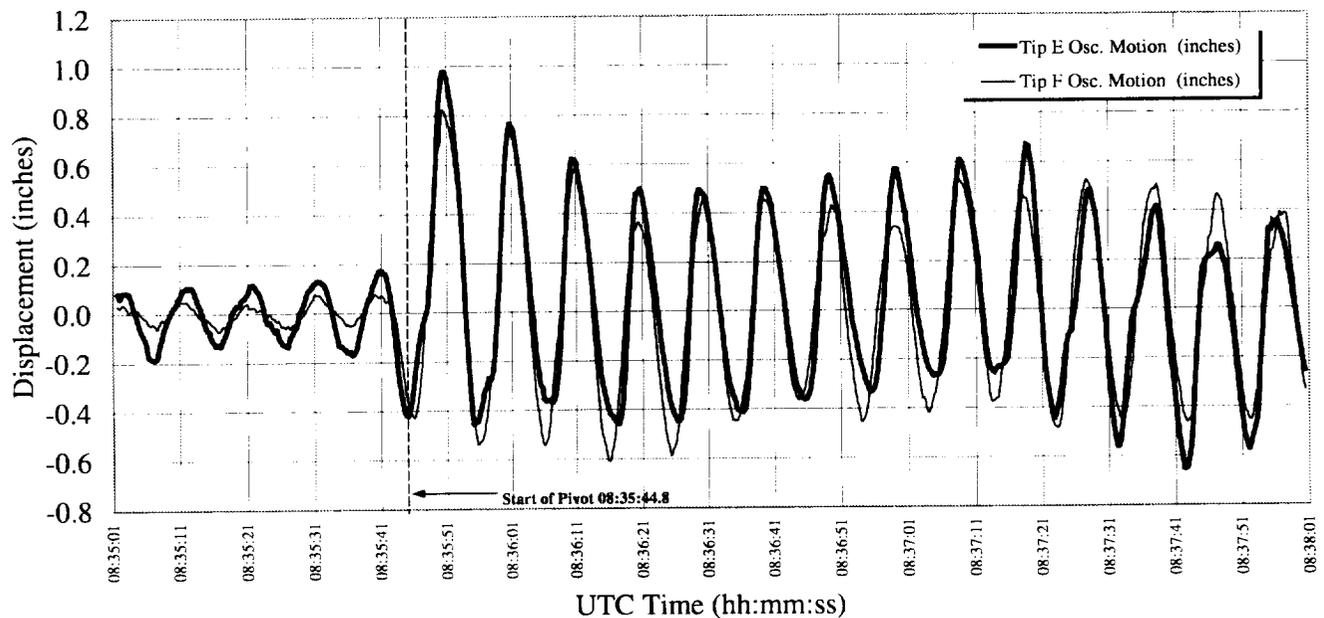
Figure 6.14 Solar array tip displacements during start of pivot event (Flight Day 8).

Figure 6.14 gives the plots of the displacements of the solar array tips as a function of time, and Appendix G contains plots showing the displacements before the translational correction. The plots in Figure 6.14 represent a smoothing of the original data using the five-point moving average filter. The raw displacement plots and the frequency plots are also in Appendix G. The maximum peak-to-peak displacement for tip E was 1.43 ± 0.14 inches at 08:35:50.46 UTC while the maximum peak-to-peak displacement for tip F was 1.36 ± 0.21 inches at 08:35:50.13 UTC. The dominant frequency for both tips was 0.1 Hz. Again note that the background motion had a peak-to-peak displacement of approximately 0.2 inches with a 0.1 Hz frequency.

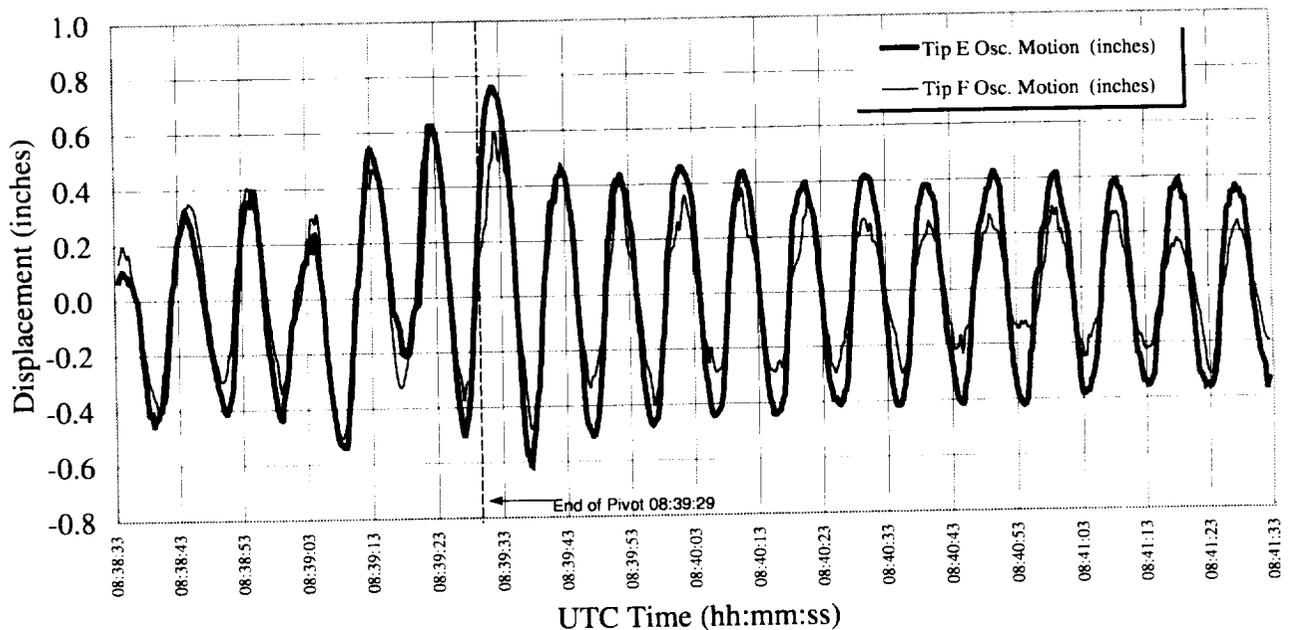
Figure 6.15 Solar array tip displacements during end of pivot event (Flight Day 8).

A 3-minute video sequence showing the end of HST pivot on Flight Day 8 was analyzed. The video sequence began at 08:38:33.0 UTC, which was just before the end of the pivot and ended at 08:41:33.0 UTC. As with the start of pivot, the RMS elbow camera was used to image tips E (inboard) and F (outboard) during the end of the pivot. Figure 6.15 gives the plots of the displacements of the solar array tips, and Appendix G contains plots showing the displacements before the translational correction. Figure 6.15 represents a smoothing of the original data using a five-point moving average filter. The raw displacement plots and the frequency plots are also included in Appendix G. The maximum peak-to-peak displacement for tip E was 1.37 ± 0.13 inches at 08:39:32 UTC and the maximum peak-to-peak displacement for tip F was 1.07 ± 0.29 inches at 08:39:32.00 UTC. Both maximum displacements occurred just as the pivot operation ended. The dominant frequency for both tips was 0.1 Hz. The accuracy for measuring the tip displacement for tip F was less than for tip E. This can be clearly seen in the raw displacement plots, with tip F being noisier. The cause for the poorer tracking for tip F was not readily apparent in viewing the imagery. No significant lighting of background changes were observed.

The tip displacements for the end-of-pivot data were noisier than those for the beginning of pivot. The lighting appeared to be stable with no noticeable shadows moving through the view. The cause for the increased noise in the data was not determined.

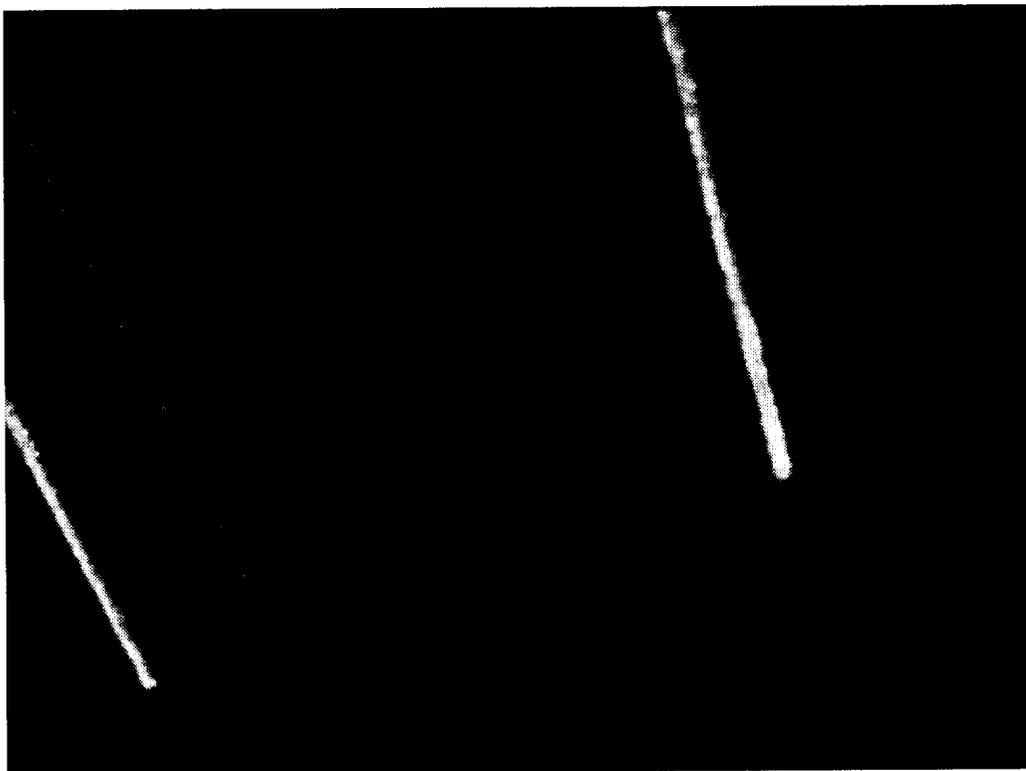
Figure 6.16 View of +V2 solar array tips A and B from camera B during reboost on Flight Day 8.

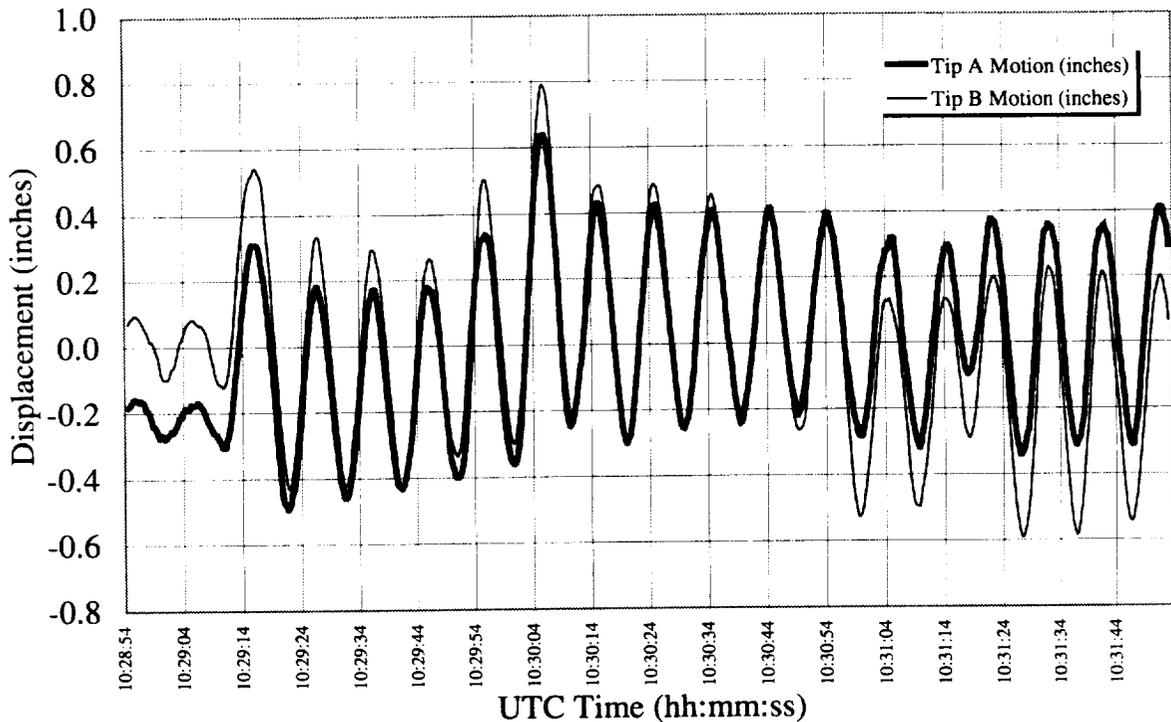
Figure 6.17 Solar array tip displacements during reboost (Flight Day 8).
