NASA/TP-98-201793

Photogrammetric Assessment of the Hubble Space Telescope Solar Arrays During the Second Servicing Mission

Final Report

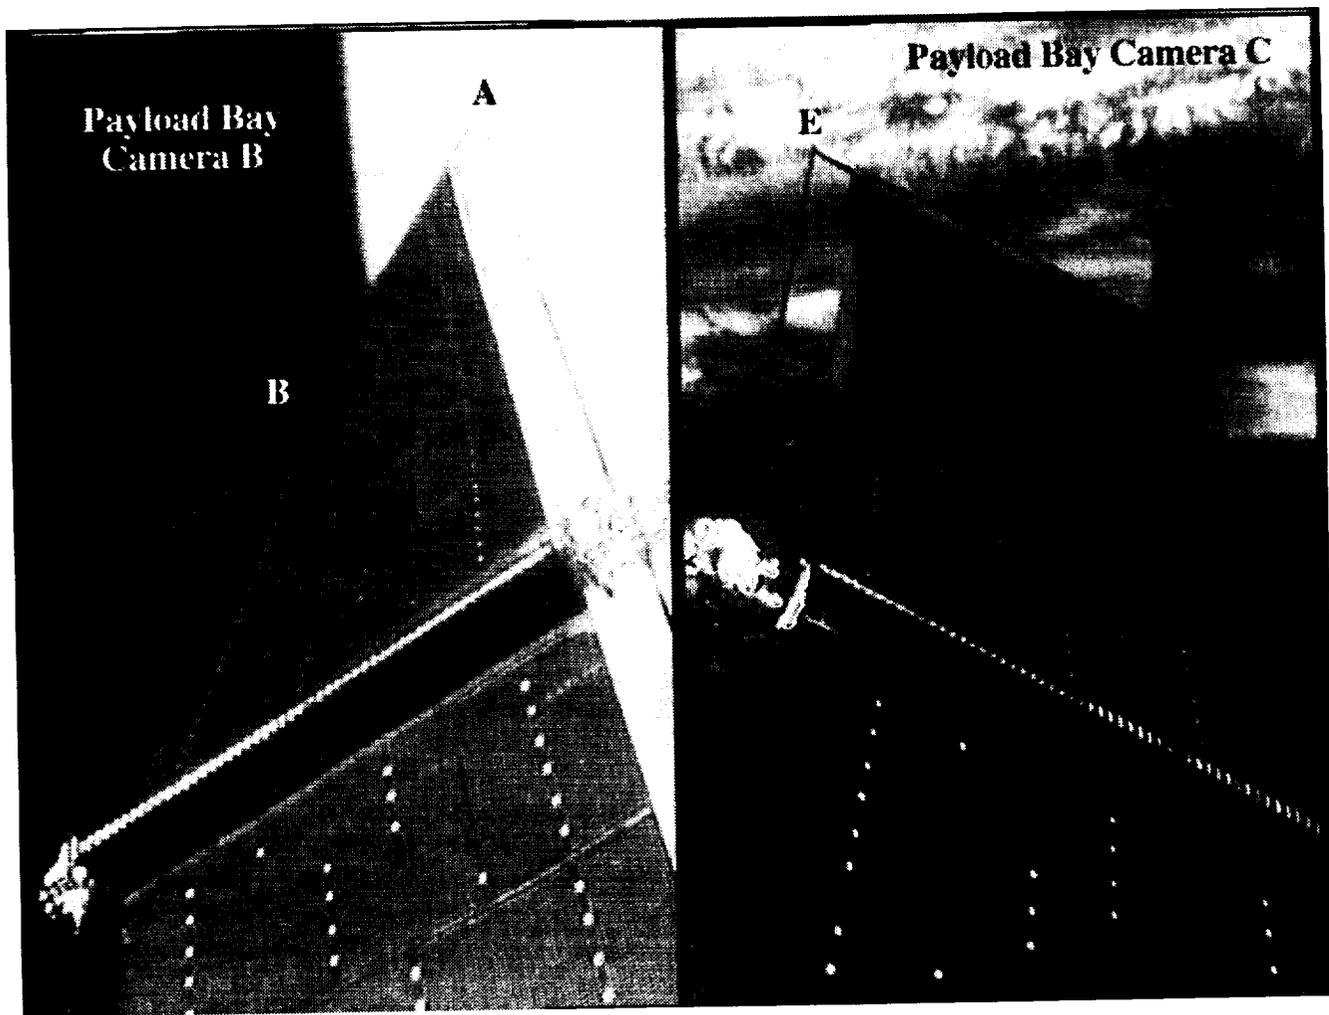
Figure 1: Frame of video from Servicing Mission 1 used in proof-of-concept analysis.
